RE: Board of Architectural Review Appeal
BAR 25-01-22
Tax Map 9 Parcel 109
Delta Zeta Annex
144 Chancellor Street
Charlottesville, VA 22902

Report with Addendum (Original report October 28, 2024)

RE: 144 Chancellor St.
Initial Structural Condition Assessment
Dunbar Project 2410-72

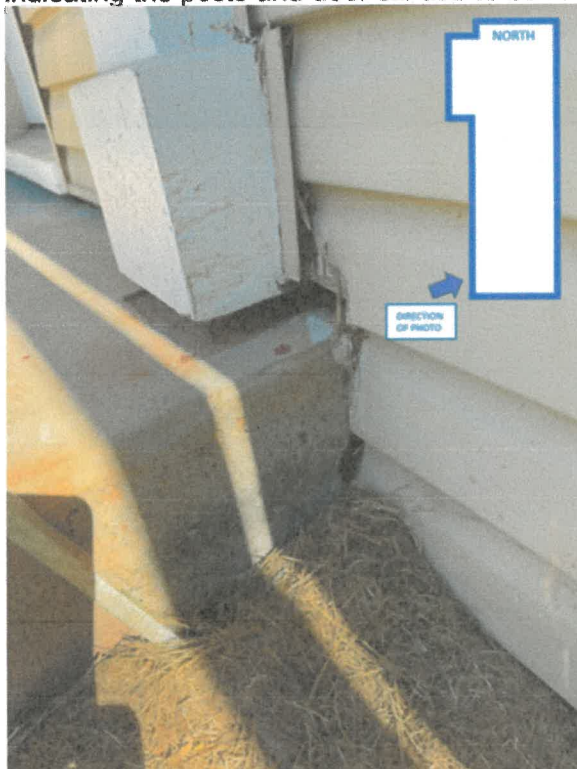
The front porch consists of a 10ft x6ft concrete slab on grade supporting the porches roof. At the building it is apparent that the concrete slab on grade has settled approximately 1 to 2" in elevation. This is apparent in the post imprints in the concrete indicating the posts and door sill use to be in close contact with the concrete slab.

Photo 1: Imprints of the post in concrete indicate the slabs original position.

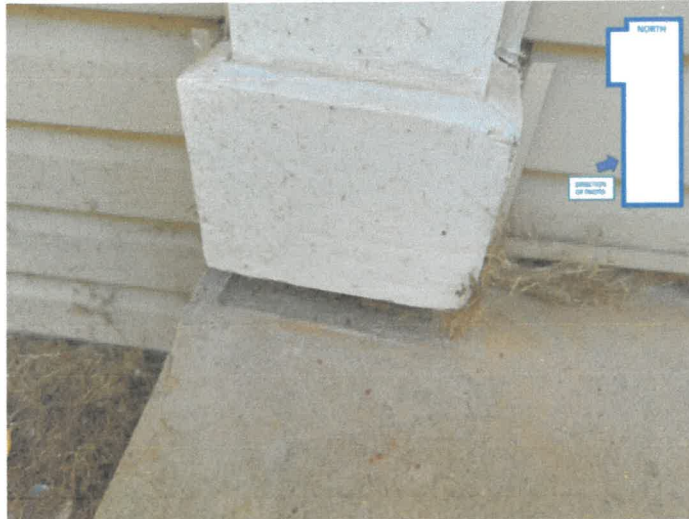
Photo 2: Imprints of the post in concrete indicate the slabs original position.

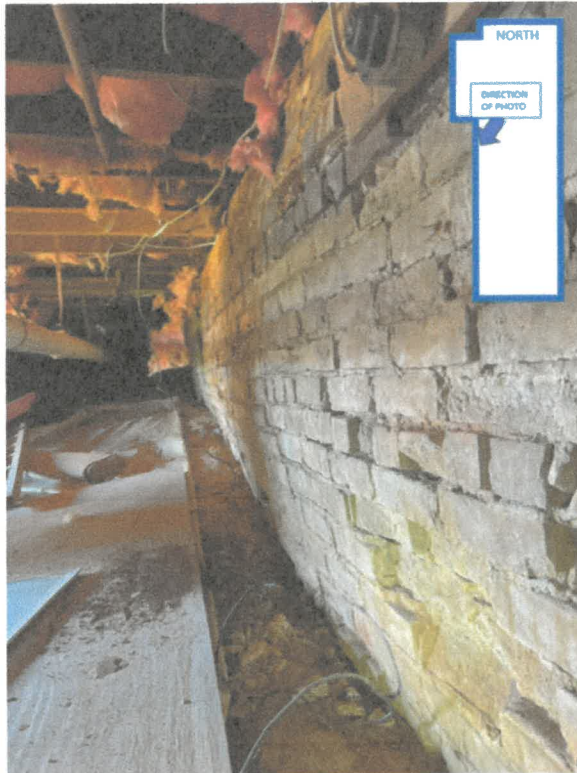
The foundation along the west side of the building consists of a solid brick masonry retaining wall of multi wythe thickness 4 to 5 ft tall within the crawl space. The earth slopes down to the wall from the road which is approximately 15ft from the building at an elevation of 2'-6" above ground floor. The wall is bowed out approximately 3 to 5". It also appears that the top of the wall has shifted laterally. There are numerous horizontal cracks at mid elevation along the wall. Several of the internal brick piers supporting the ground floor are out of vertical by up to 2". The ground within the crawl space appears to be damper than normal considering we have not had any precipitation in the past few weeks.

Photo 3: West side retaining wall with significant bow.

Lateral earth pressure along the west side is displacing the building and causing cracking and failure of the brick retaining wall. This is compounded by water runoff pressing against the wall as well. The presence of horizontal cracks along the mortar as well as the bow in the wall indicates the brick wall is failing in flexure. This bow may be the result of why the slab on grade at the porch has dropped 1 to 2" relative to the ground floor. Indications that all of the brick piers have shifted at the top towards the east (downslope) also indicates that the entire building has shifted downslope as well.

- Excavate and remove the existing backfill along the west side of the building.
- Repair or replace the existing brick retaining wall. This would consist of 35ft of wall.
- Install a foundation subdrain that outlets to daylight or suitable drain. Install a waterproofing system against the below grade walls. Replace backfill along the west wall with an open graded stone such as VDOT No. 57.
- Connect the perimeter CMU infill to the brick masonry piers. This could be accomplished with a 2x ledger board and adhesive anchors.
- Connect the building perimeter sill plate to the CMU infill walls.
- Generally performed repairs to the damaged and cracked masonry. This work would involve extensive repointing.

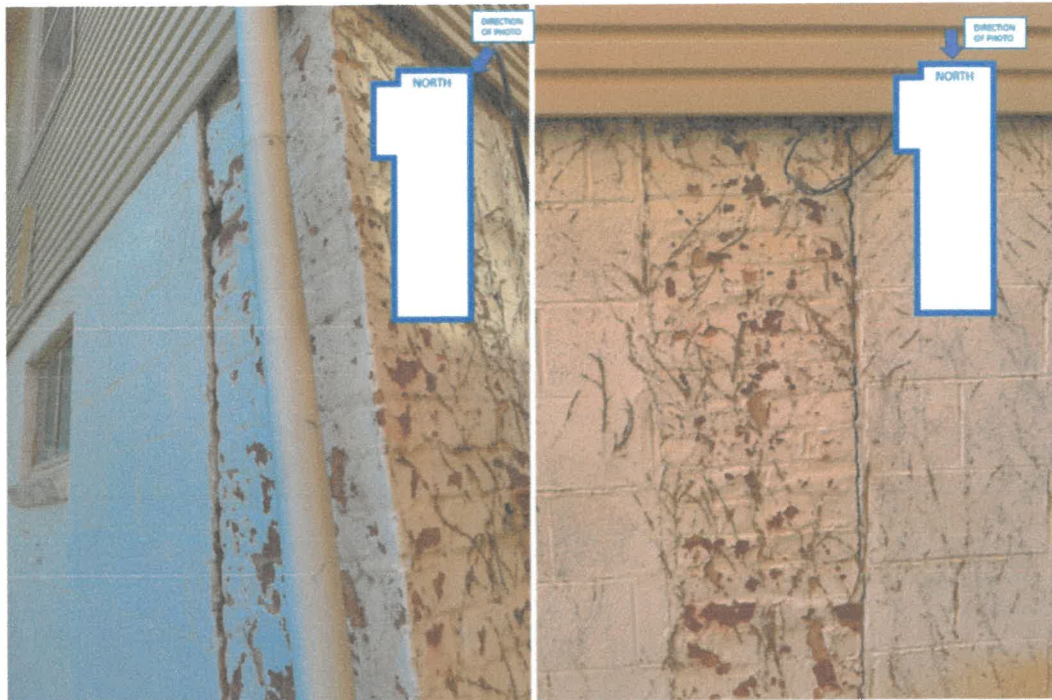
Along the perimeter of the building, the brick piers appear to be leaning towards downslope (easterly direction) as well. This reinforces the sense that the building has shifted laterally down slope potentially a couple of inches.

Photo 4/5: Perimeter piers with gaps between CMU infill and piers being larger at top.

There is CMU infill along the south, north and east side in between the perimeter brick piers. These walls do not appear to be connected to the piers or the ground floor as evidence that these walls can move laterally simply by pushing them and that there are noticeable gaps in the piers and the CMU infill. Note these gaps tend to be wider at the top of the wall further indicating the piers have shifted down slope.

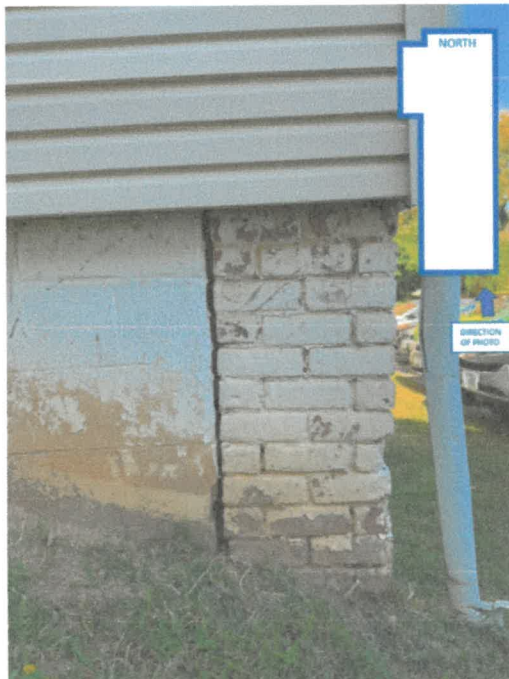
Photo 6: Perimeter piers with gaps between CMU infill and piers being larger at top.

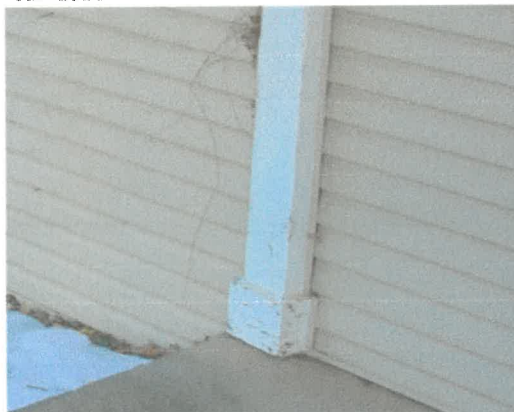
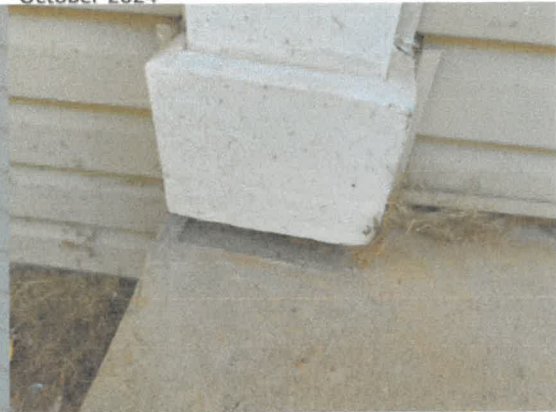
Front porch slab on grade has settled. We believe this is due to the movement of the retaining wall at this location.

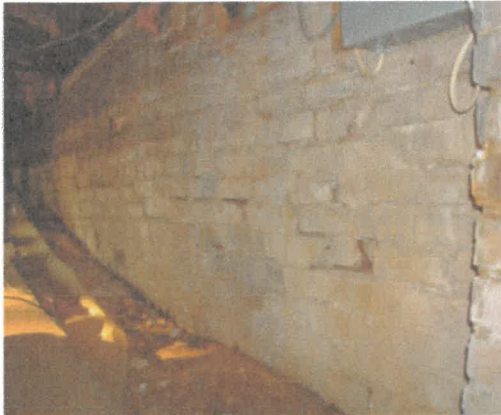
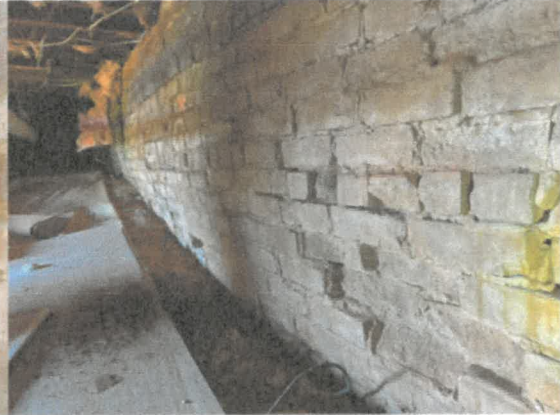
West side retaining wall, the later photo appears to show the wall has curved out more.

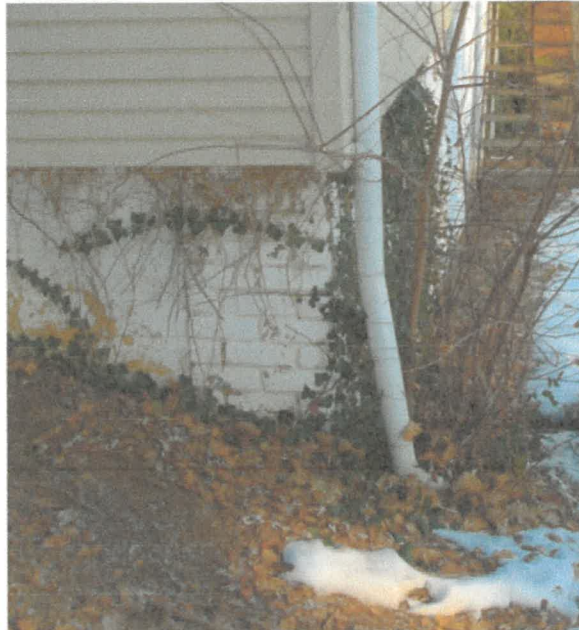
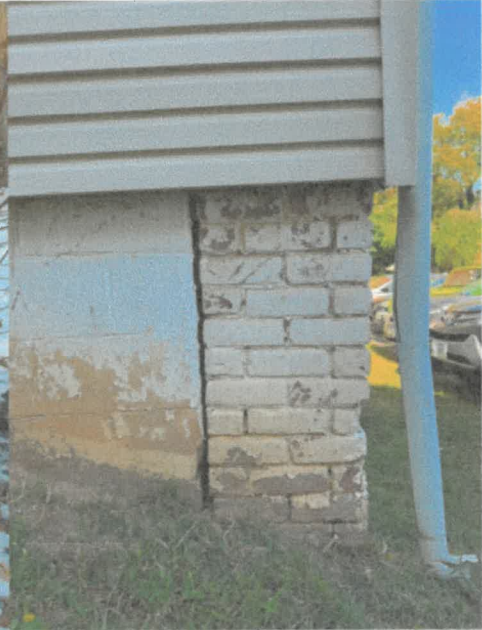
Corner masonry pier on the south eastern corner of the building. The later photo shows a gap of approximately $\frac{3}{4}$ " that does not appear in the 2010 photo. This supports our observations that the building may be shifting east.
