Charlottesville Downtown Mall **TREE MANAGEMENT PLAN**

CITY COUNCIL MEETING

September 3, 2024

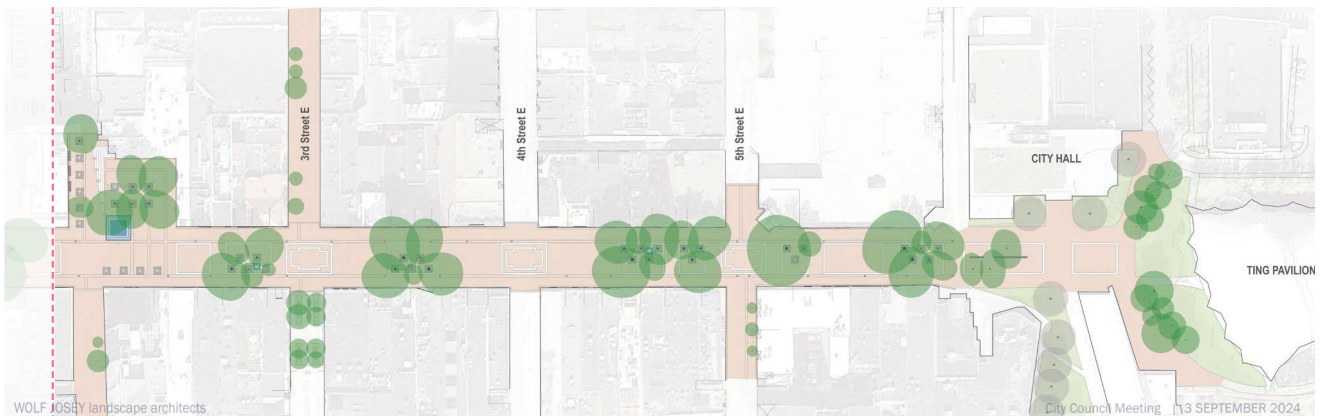
Existing Trees | Inventory

- 109 trees
(not including 15 removed trees)

- Existing trees
- Adjacent trees not in study area

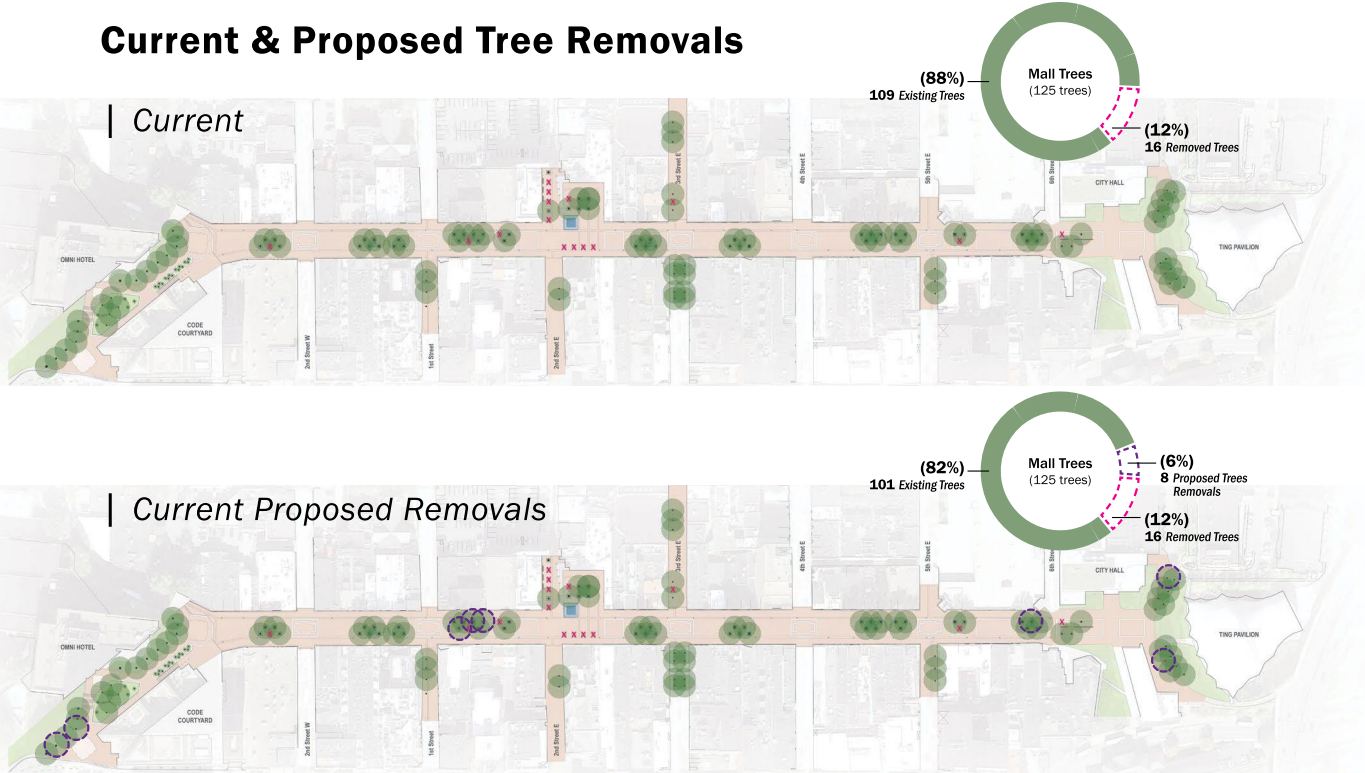
Current & Proposed Tree Removals

Existing Trees | Tree Health & Proposed Removals

Some trees are in such an advanced stage of decline that trying to retain them seems futile. They may also represent an unacceptable level of risk. Trees #54 and 59 are in this condition now and should be considered for removal.

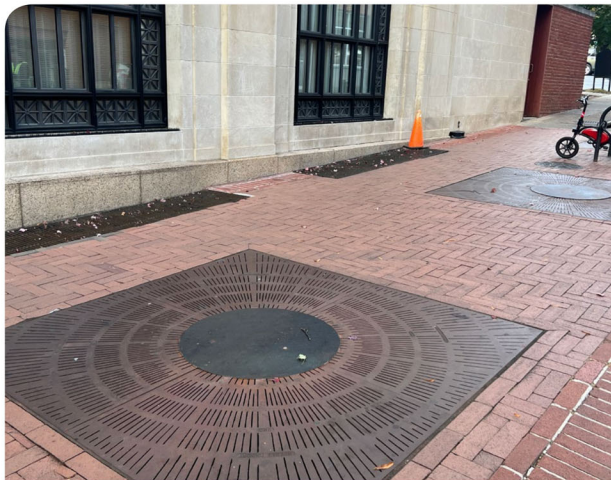
LIMITED SOIL VOLUME

- Minimal soil volume between building foundation soils and step footers
- Planted maples have limited urban adaptability and lead to high mortality

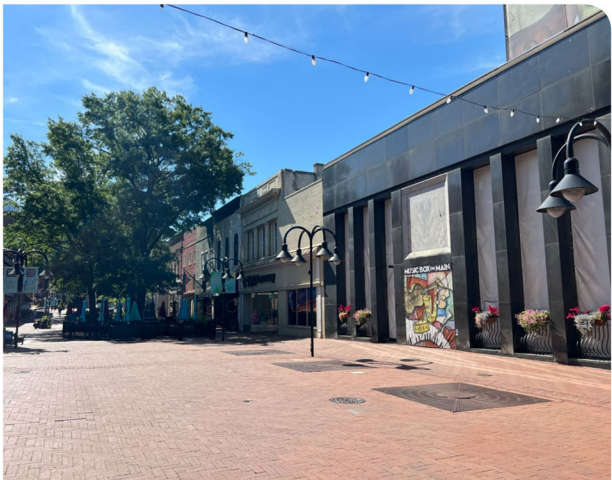
SATURATED SOILS

- No drainage infrastructure and location has lead to higher saturated soil levels

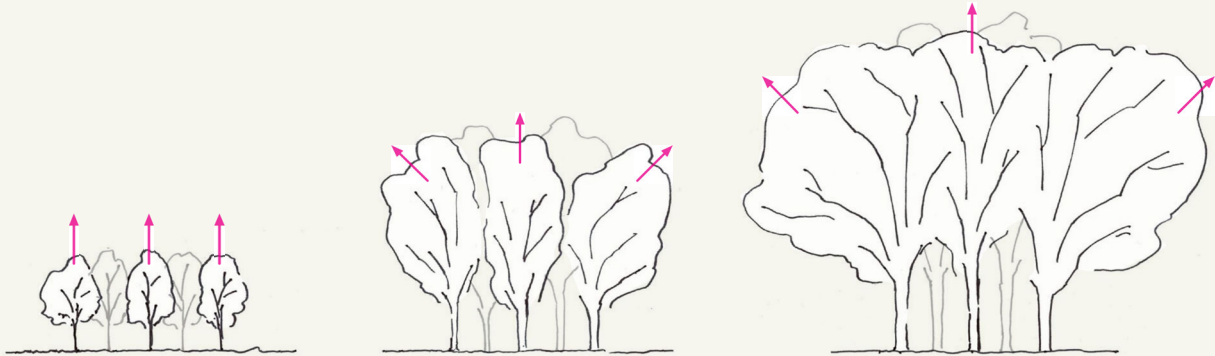
Replacement Trees | Uniform Grove Replacement *(proposed)*

- Trees planted at the same time grow together as a single form

- As the trees mature, the perimeter trees are pruned allowing more light to interior trees

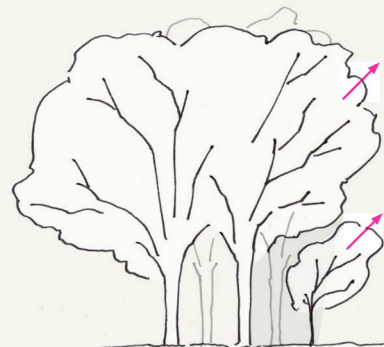
Replacement Trees | Single Tree Replacement *(not proposed)*

- Young trees struggle to develop in the shade of other trees for irregular growth rates

- Mature trees and new trees compete to fill light gaps from removed trees

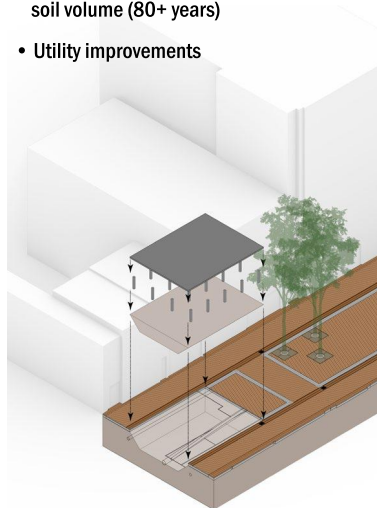
- ① Demo trees/pavements & remove existing soil for possible reuse

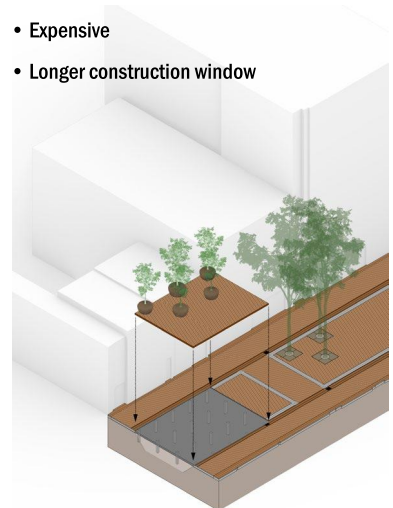
- ② Update water and gas laterals, install structural columns and planting soil

- ③ Install hidden paver grate, pavers, irrigation and trees

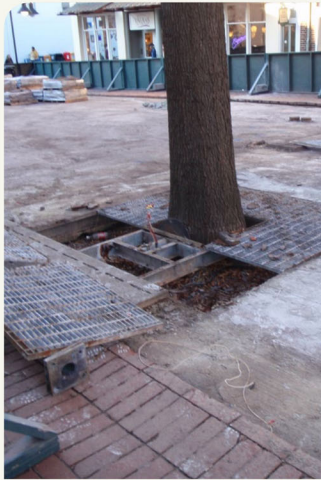
Halprin Design: Hidden Paver Grate

- Benefits:
 - Continuous paving to trunk creates uniform ground plane and contiguous appearance

Preferred approach

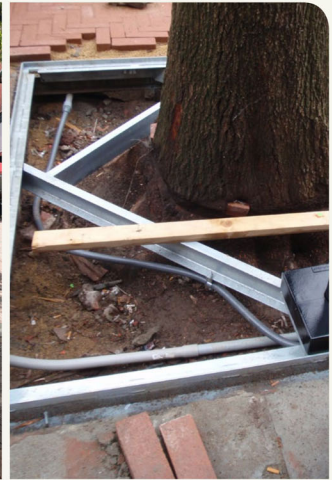
2009 Design Modification: Surface Grate

- Benefits:
 - Girdling by surface grate is more visually apparent.
 - Removes brick masonry modification

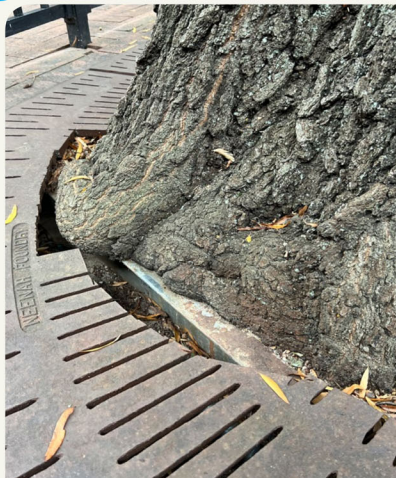
Tree #13

- Tree girdled by grate support beam

- Visible damage to trunk from grate
- Root flare girdled by both surface grate and structural grate support
- Grate not designed for expansion

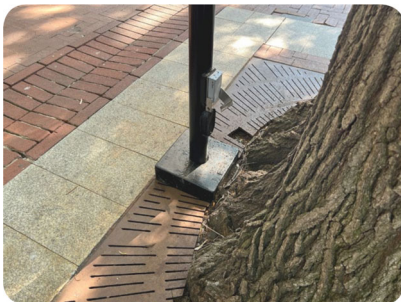
Modify light and driver relocation

- Locate Fixture in corner for greatest distance from tree trunk
- Fixture footing to be flush with grate to reduce trip hazard

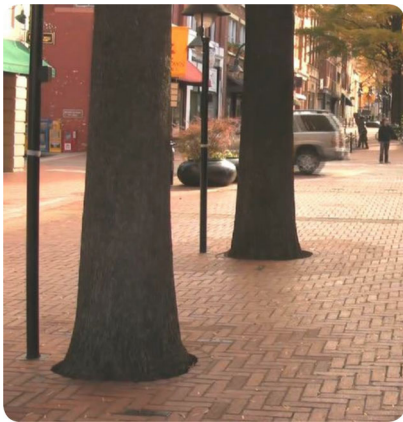
Proposed Replacement Detail

Replace grates with pavement and foam support structure

- Restore original design intent
- Transition detail to be applied to proposed trees replacements when grates are outgrown
- Paver grates from new tree planting to be replaced with foam support after 30 years

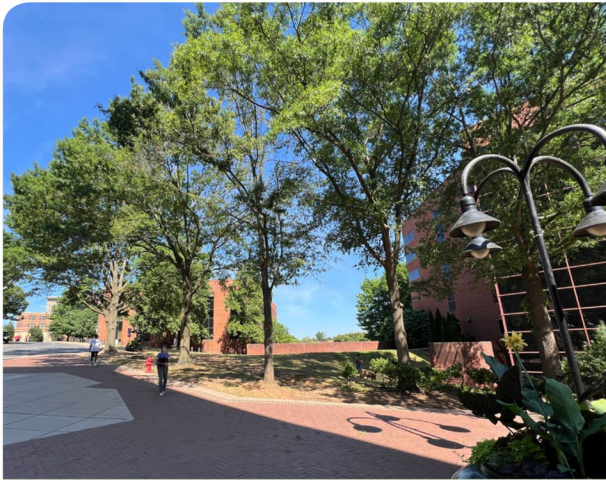
CANOPY CROWDING

- Selectively prune and thin trees to reduce crown competition and building conflicts
- Trees are generally healthy

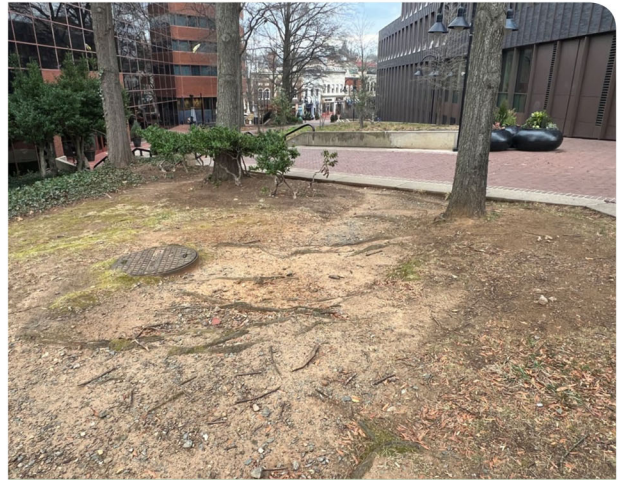
POOR SOIL CONDITIONS

- Apply mulch or chips to exposed soils reducing compaction / improve nutrient holding

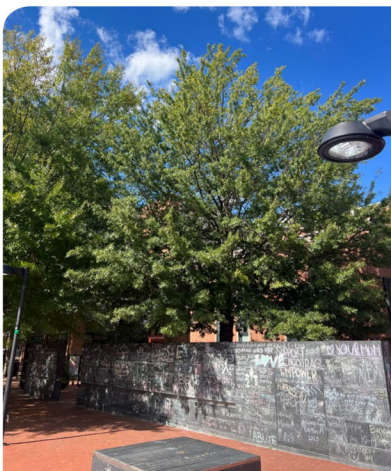
OVERALL CONDITIONS

- Trees are generally healthy

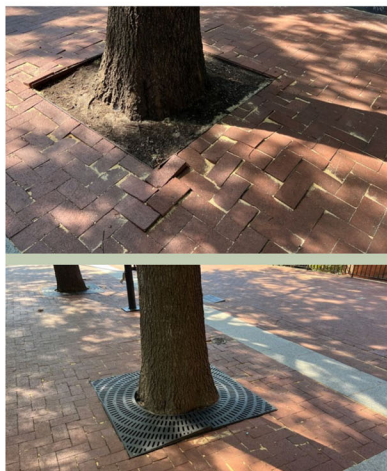
GRATE CONFLICTS

- Surface roots between slab and pavers leading to trip hazards
- Hidden steel paver grate girdling trees

Short Term: Modify Grates

- Replace hidden paver grates
- Prune adventitious roots beneath pavers and reset pavers on slab

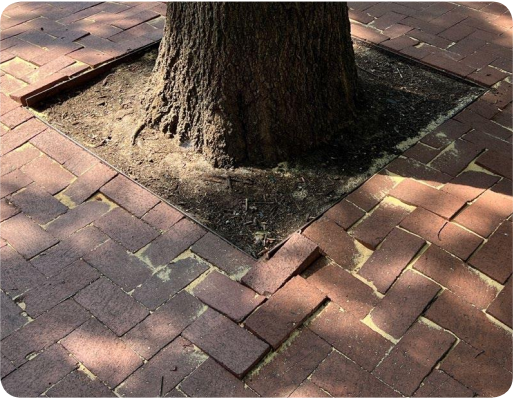
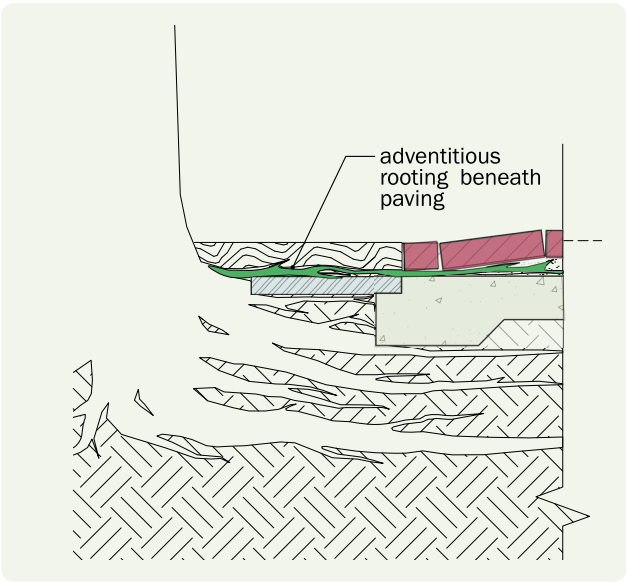
Tree Paver Grate Modification

Existing tree grate conditions below grade at the Freedom of Speech Wall are unknown and based on suspected conditions.

A structural steel hidden paver grate appears to be girdling the tree with adventitious roots growing between the grate and pavement, causing pavers to raise and buckle

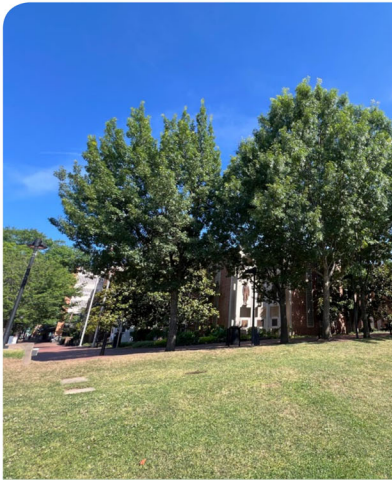
POOR SOILS

- Heavy compaction from events
- Poor nutrient holding

PAVER GRATE CONFLICTS

- Steel frame of hidden paver grates girdling trees

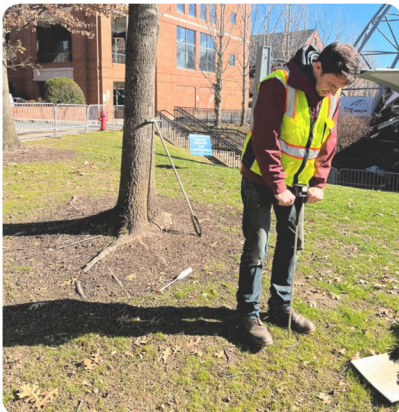
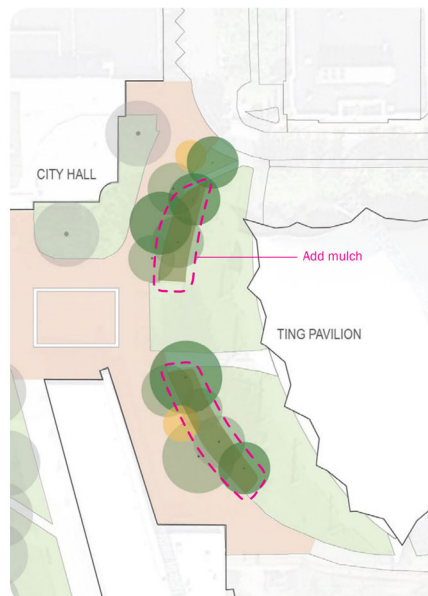
Short Term: Mulching

Add mulch around trees to reduce compaction and moisture retention

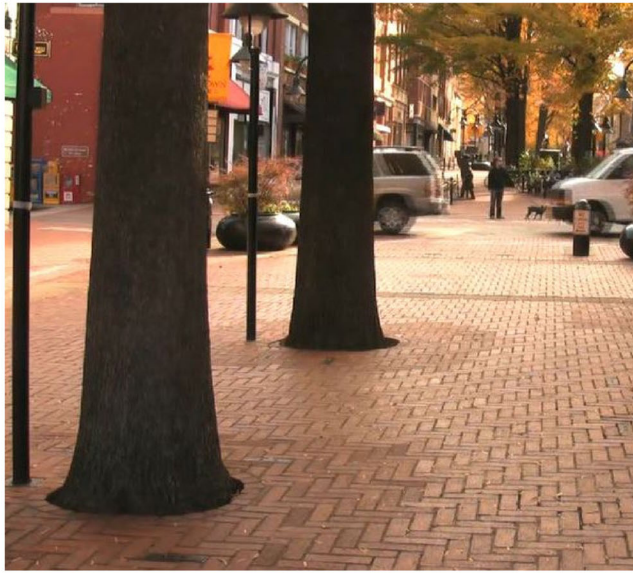
Clear views of the trunks emphasize the public nature of trees

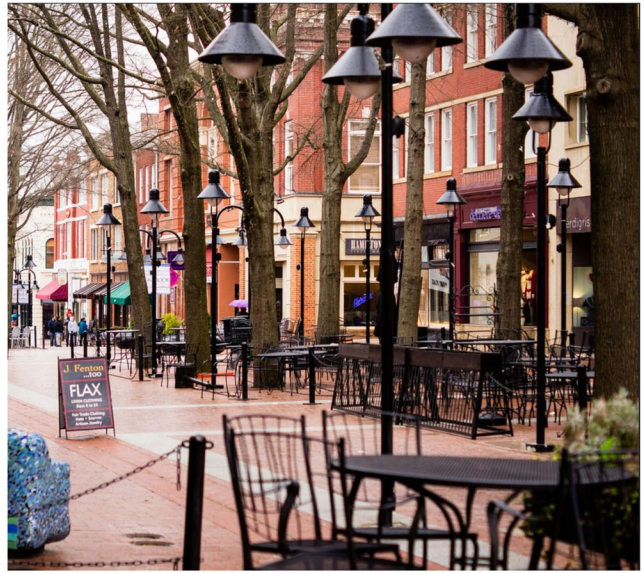
Cafe zones generate economic revenue but declare the trees as private

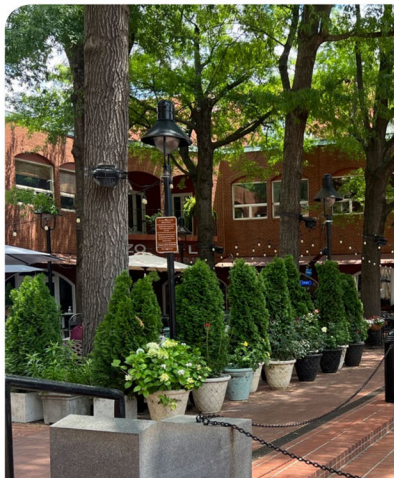
Potted Trees

- Tall vegetation (small trees) enclose and obscure base of trees
- Extensive use of pots obscures base of trees

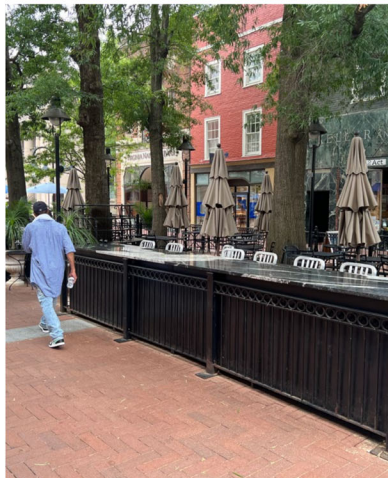
Cafe Fencing / Counters

- Solid fencing obscures base of trees
- Solid counters obscure base of trees

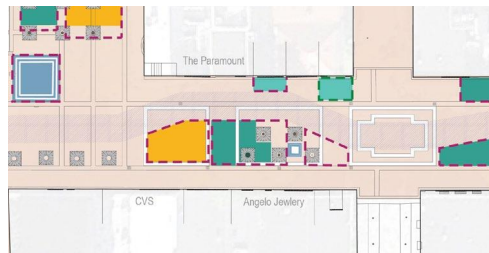
Fountain C

- Reveal fountain and willow oaks from east
- Net change: -927 SF

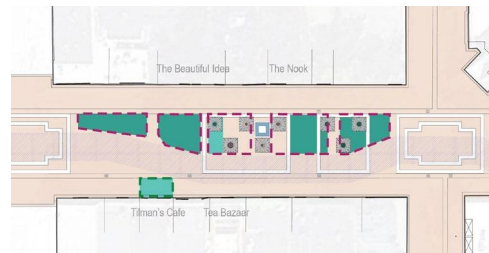
Fountain D

- Reveal fountain and trunks within grove of willow oaks
- Net change: -690 SF

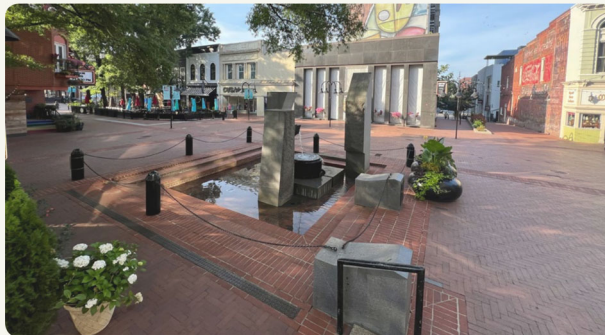
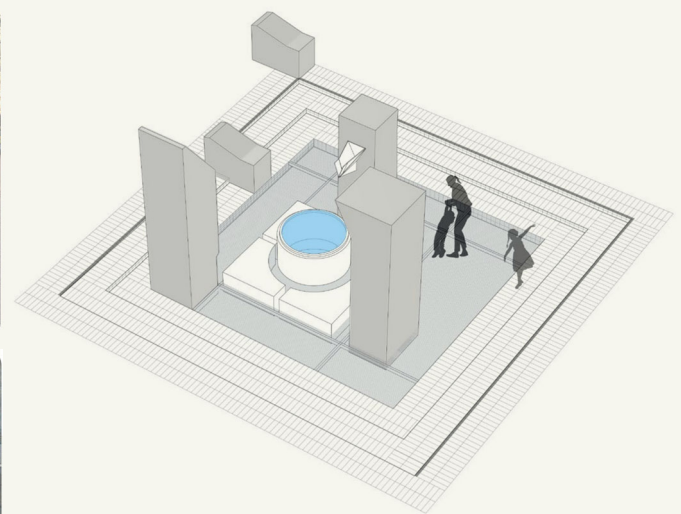
Recommendation:

- Add level and accessible stainless grate over basin
- Add safety nosing at stairs (remove bollards)
- Add nearby seating for visitors/families

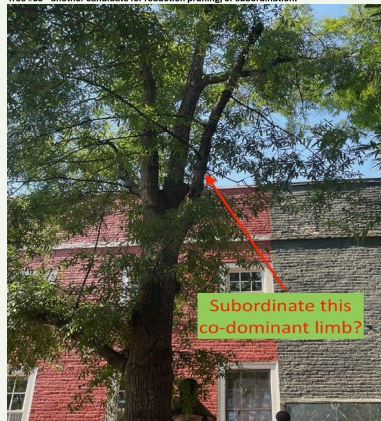
Tree #33 – another candidate for reduction pruning, or subordination.

This limb in tree #33 has been poorly pruned. This is a heading cut that is detrimental to the tree. It is probably best to prune the limb back to the branch collar at the trunk and accept that there would be a wound larger than is desired but understand that we are eliminating a co-dominant stem.

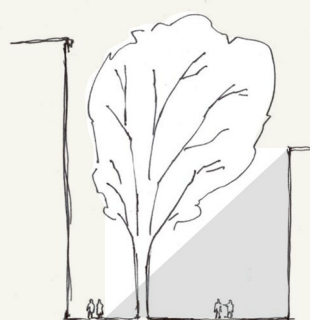
Existing Condition

Currently, tree canopies grow above buildings for sunlight

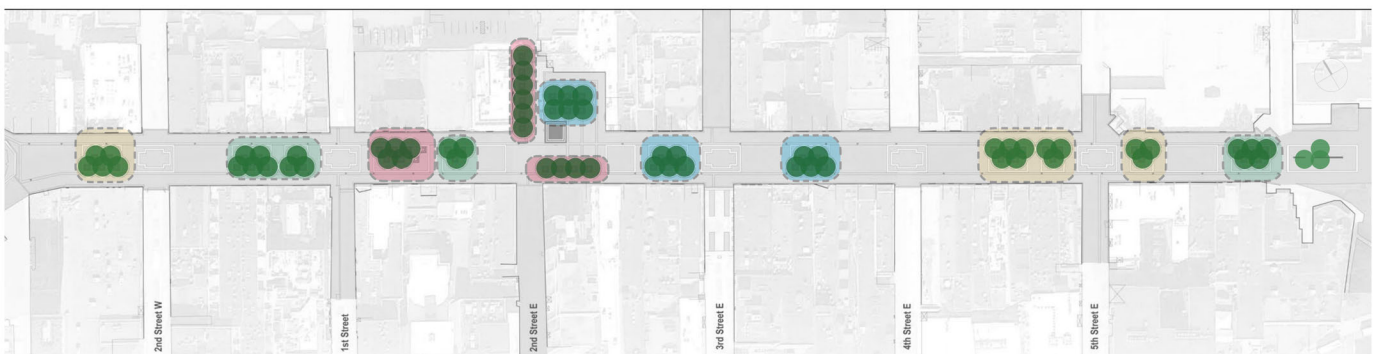
Phases 2, 3 & 4 | Staggered Phasing Plan

- 4 phase plan over 20 years to keep the mall shaded and active through the duration of the replacement
- Strategically replace bosques to reduce negative impacts to businesses

Phase 1 Year 5 Phase 2 Year 10 Phase 3 Year 15 Phase 4 Year 20

- Begin with Central Place maple replacement and least healthy bosque to introduce project and inform public of the process

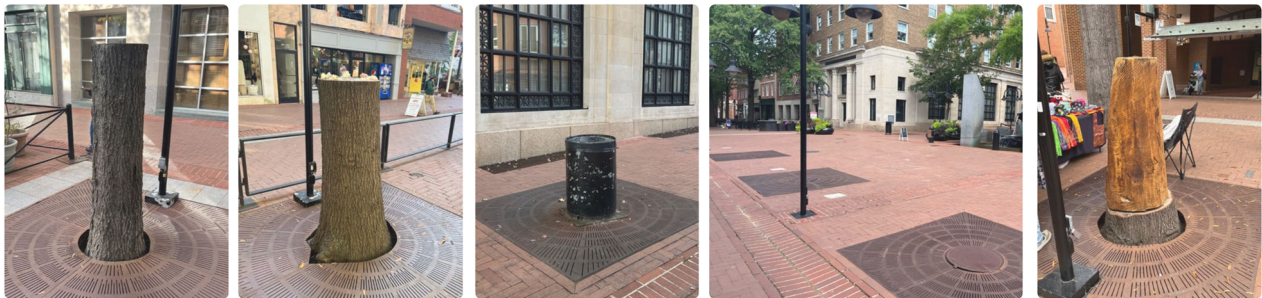
| Today

Projected Lifespan without intervention
