RE: Board of Architectural Review Appeal
BAR 25-01-22
Tax Map 9 Parcel 109
Delta Zeta Annex
144 Chancellor Street
Charlottesville, VA 22902

Report with Addendum (Original report October 28, 2024)

RE: 144 Chancellor St.
Initial Structural Condition Assessment
Dunbar Project 2410-72

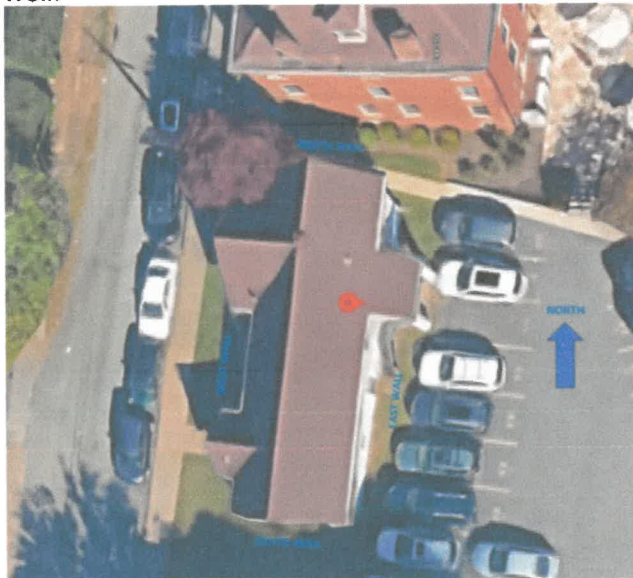
The existing building is a one-story house built around 1900 with the exterior dimensions of approximately 20ft x 56ft. The structure consists of a wood frame construction being supported by a solid brick retaining wall along the west side and brick piers around the remaining perimeter with interior piers supporting the floor as well.
