**Packet Guide
City of Charlottesville
Board of Architectural Review
Regular Meeting
December 20, 2022, 5:30 p.m.
Hybrid Meeting (In-person at CitySpace and virtual via Zoom)**

BAR # 22-12-02

116 West Jefferson Street, Tax Parcel 330183000

Project: Porch reconstruction, alterations to rear addition

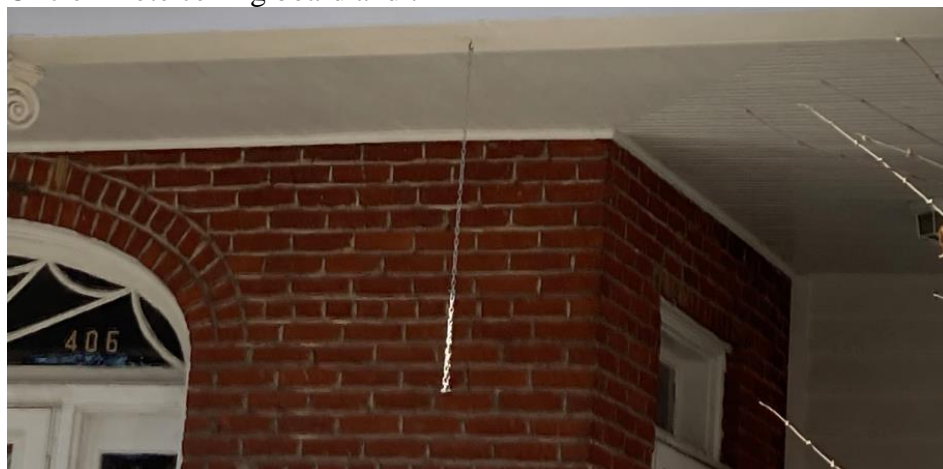
406 Altamont Circle – note ceiling board and trim

Note: Except for the cornice detail, in the event of an unknown detail, applicant shall look to existing conditions on houses of a similar period, such as 406 Altamont Circle.

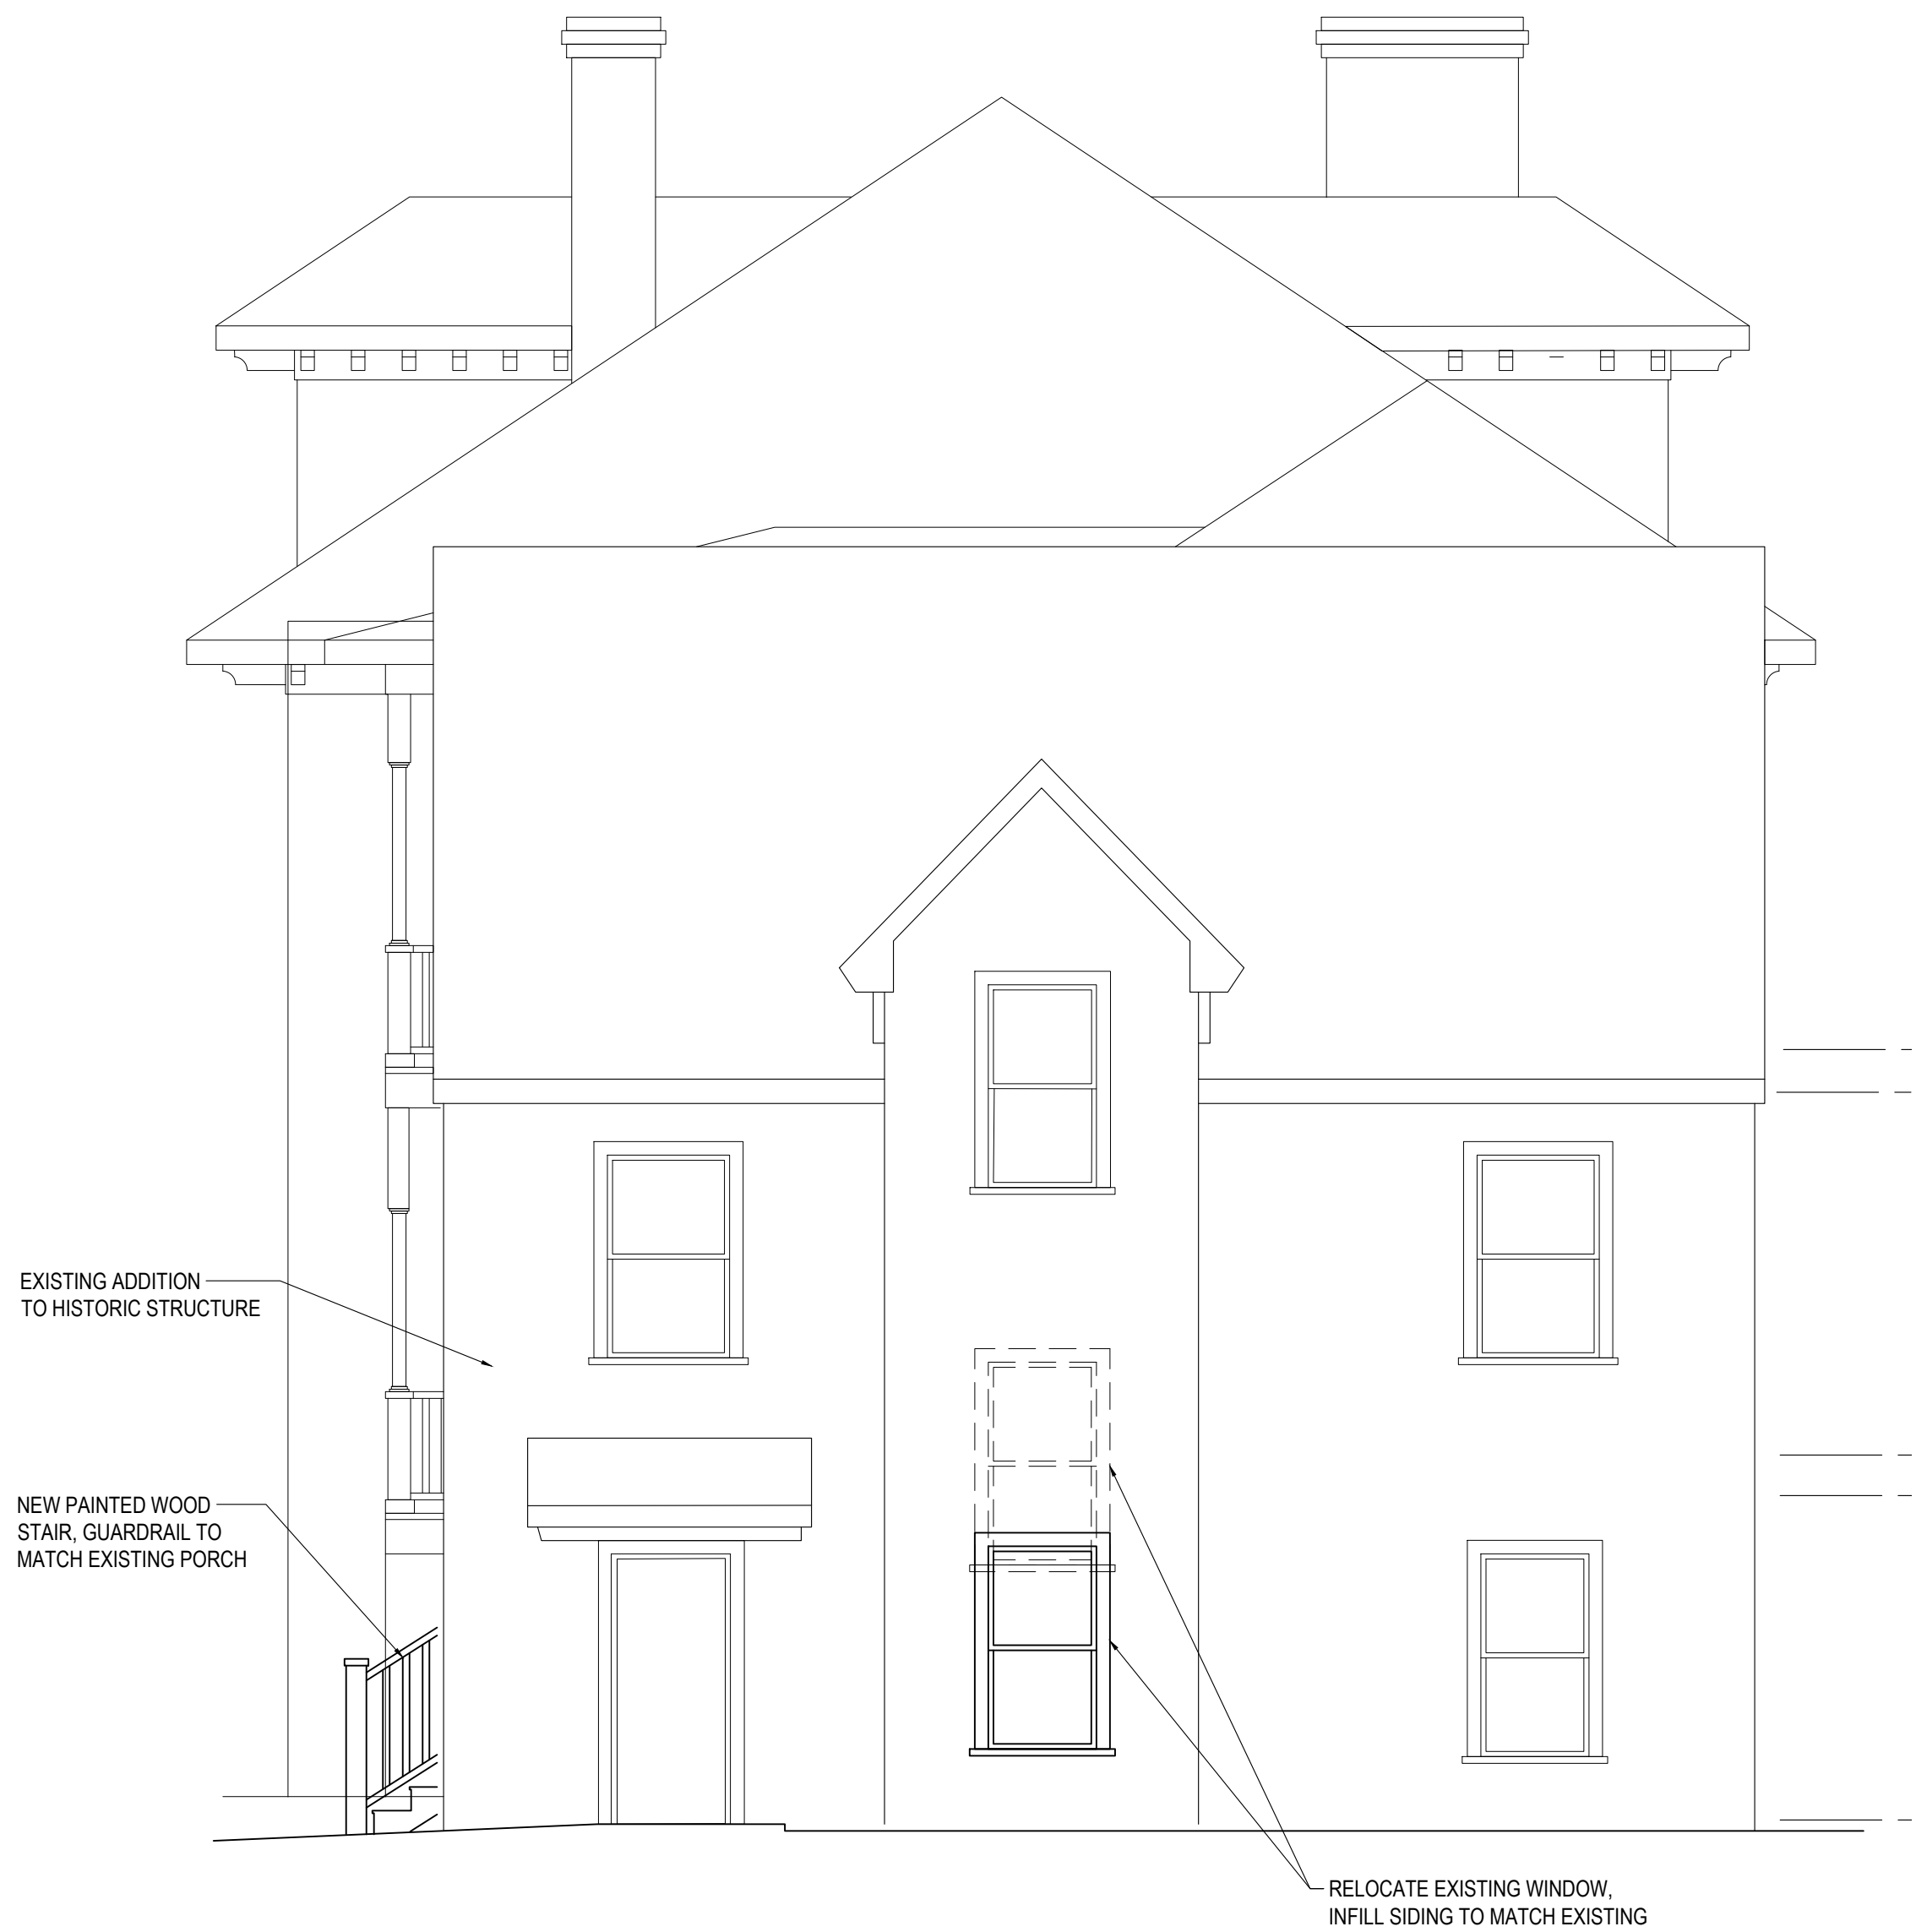
Detail from porch reconstruction at 201 East High Street. [Reference is to gutter condition only.]

201 East High Street: Porch Cornice
Drawings submitted for BN-20-0076
Modification per BAR CoA 7/16/2019

STANDING SEAM MTL. ROOF - 20" PANEL
 UNDERLAYMENT AS RECOMMENDED PER ROOFING MANUF.
 5/8" PLYWD. OR OSB
 ROOF TRUSSED @ 24" O.C.
 2 x 4 SUB FASCIA
 MTL. ROOF EDGE
 6" COPPER HALF ROUND GUTTER
 1 x 6 FASCIA
 SOFFIT BD.
 DENTIL CROWN MOULD - MATCH EXIST.
 1 x 12 BOTH SIDES

Staff recommends approval with a condition that the new hanging gutters will retain the existing profile of the upper cornice, per the rough sketch below. (Similar to the CoA condition applied to the porch roof at 201 E. High Street, July 2019.)

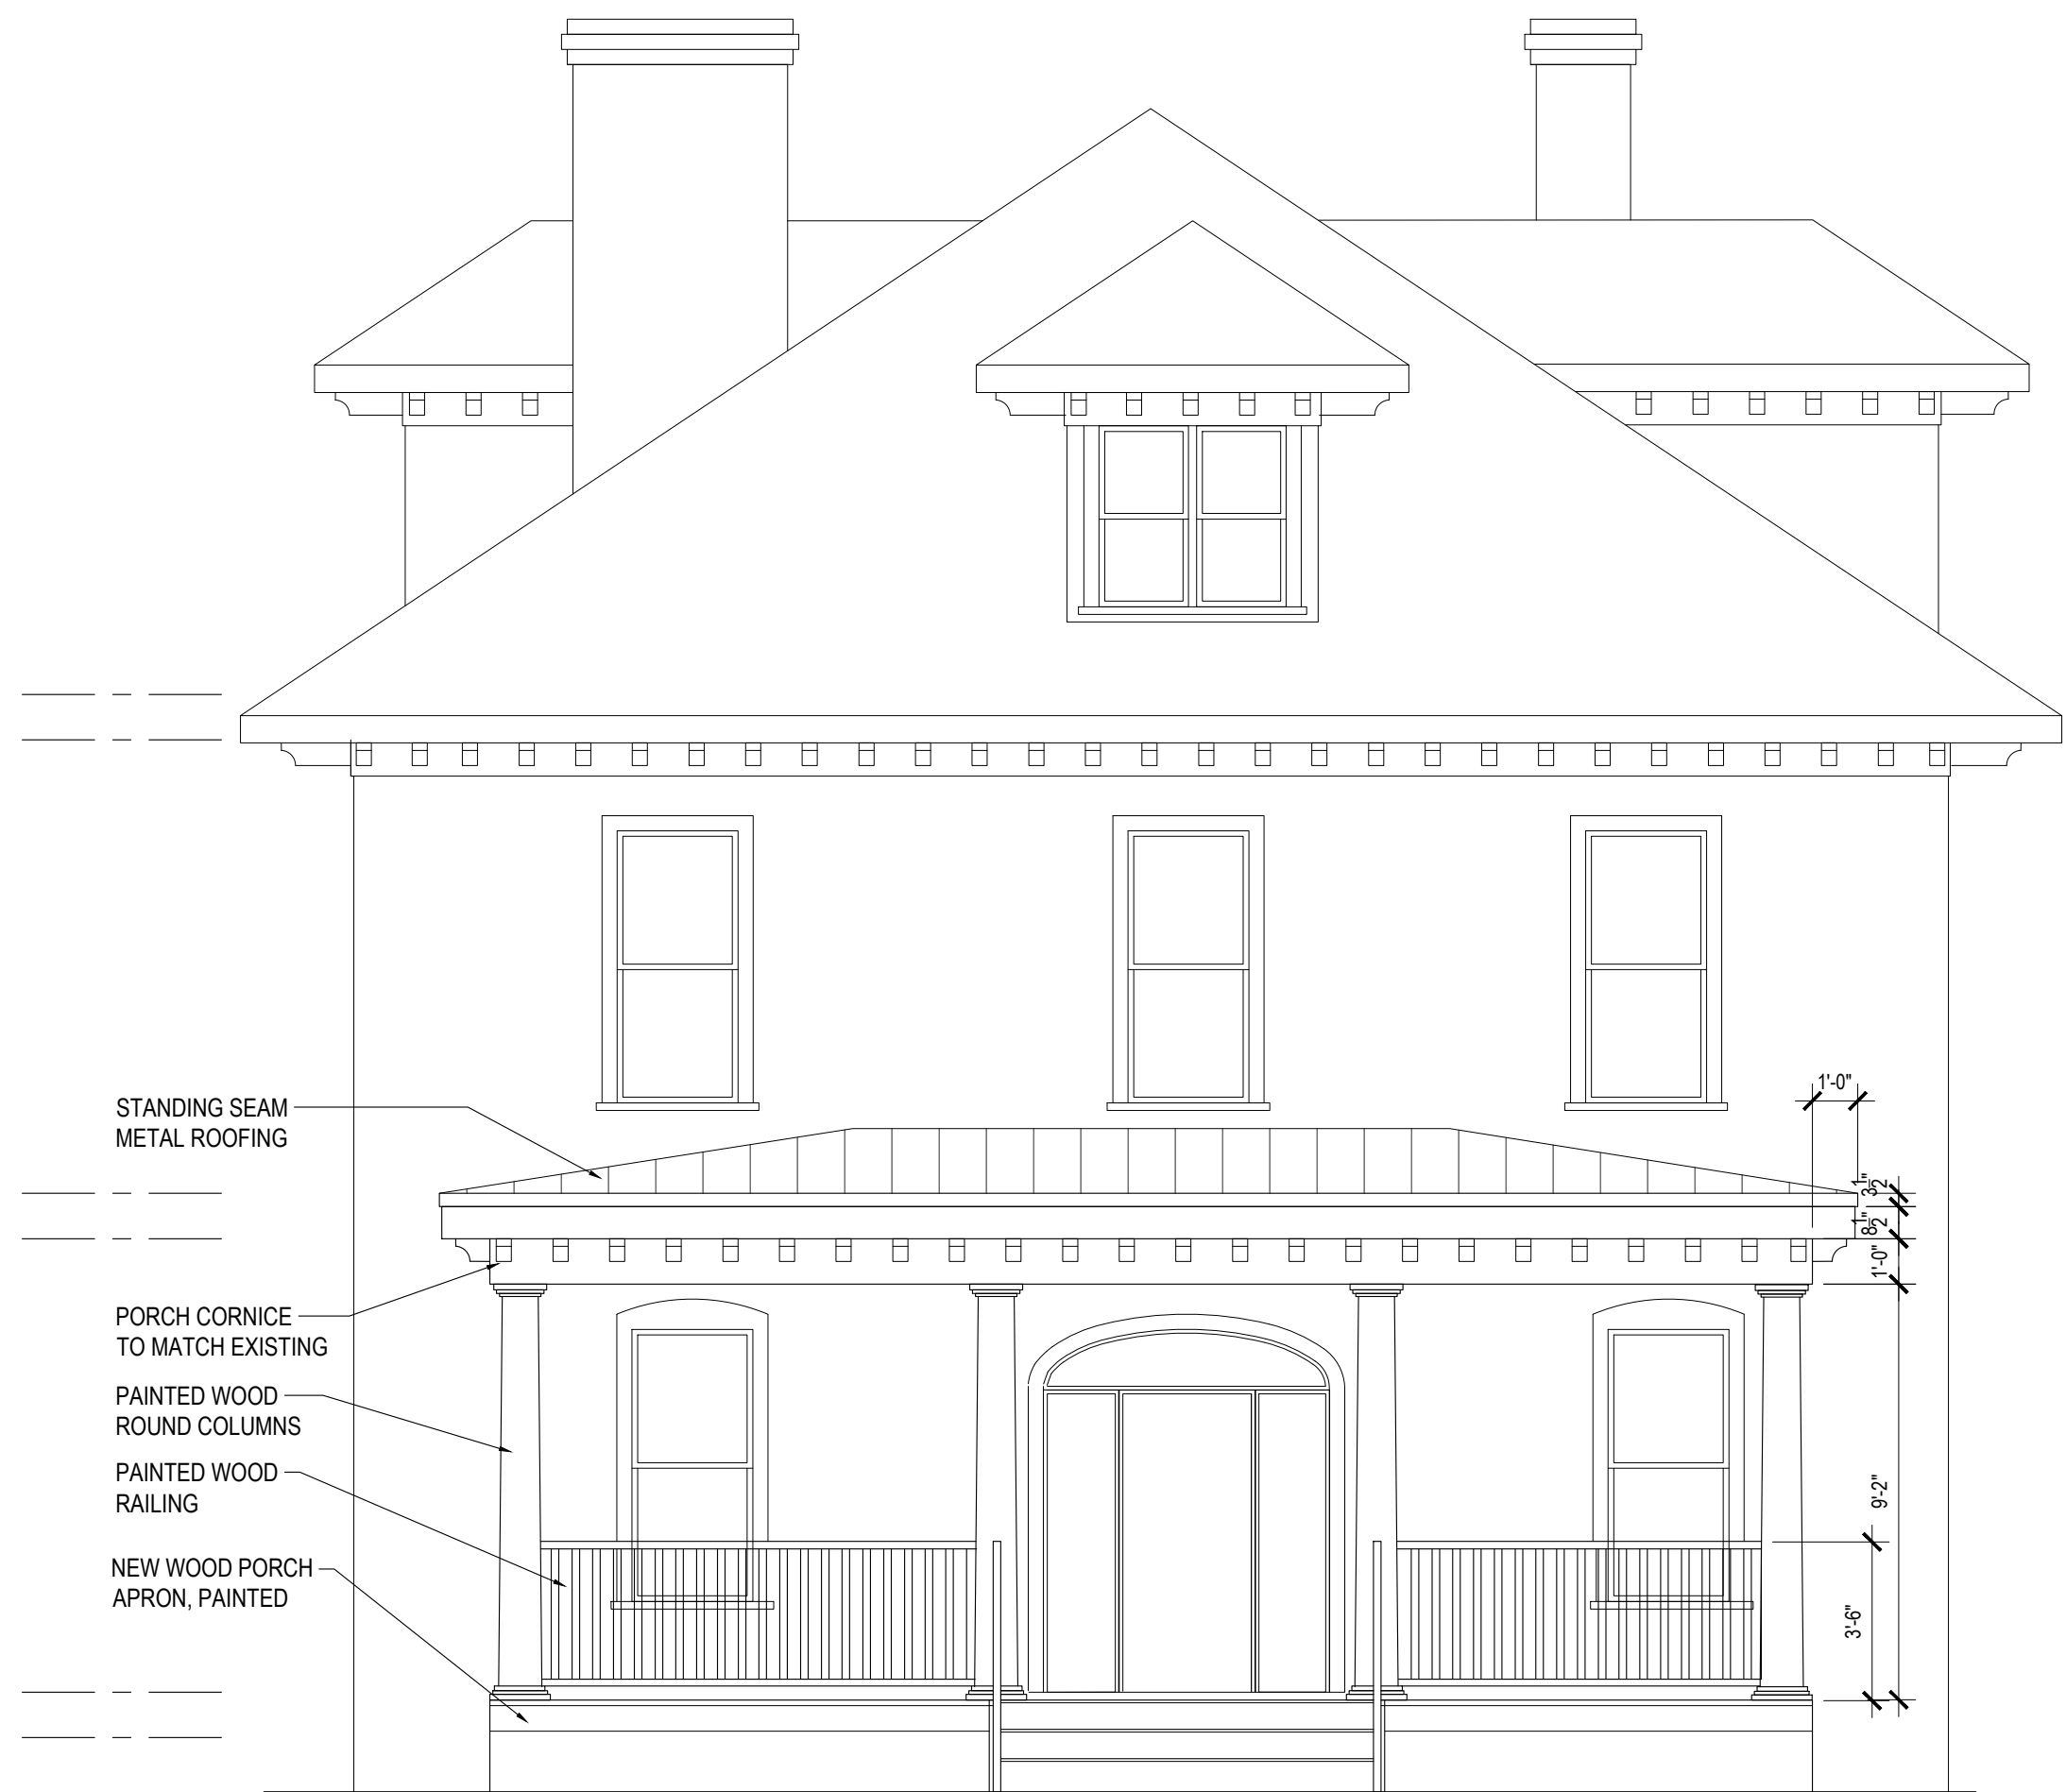
EXTERIOR ELEVATION - WEST PORCH ELEVATION
116 WEST JEFFERSON STREET

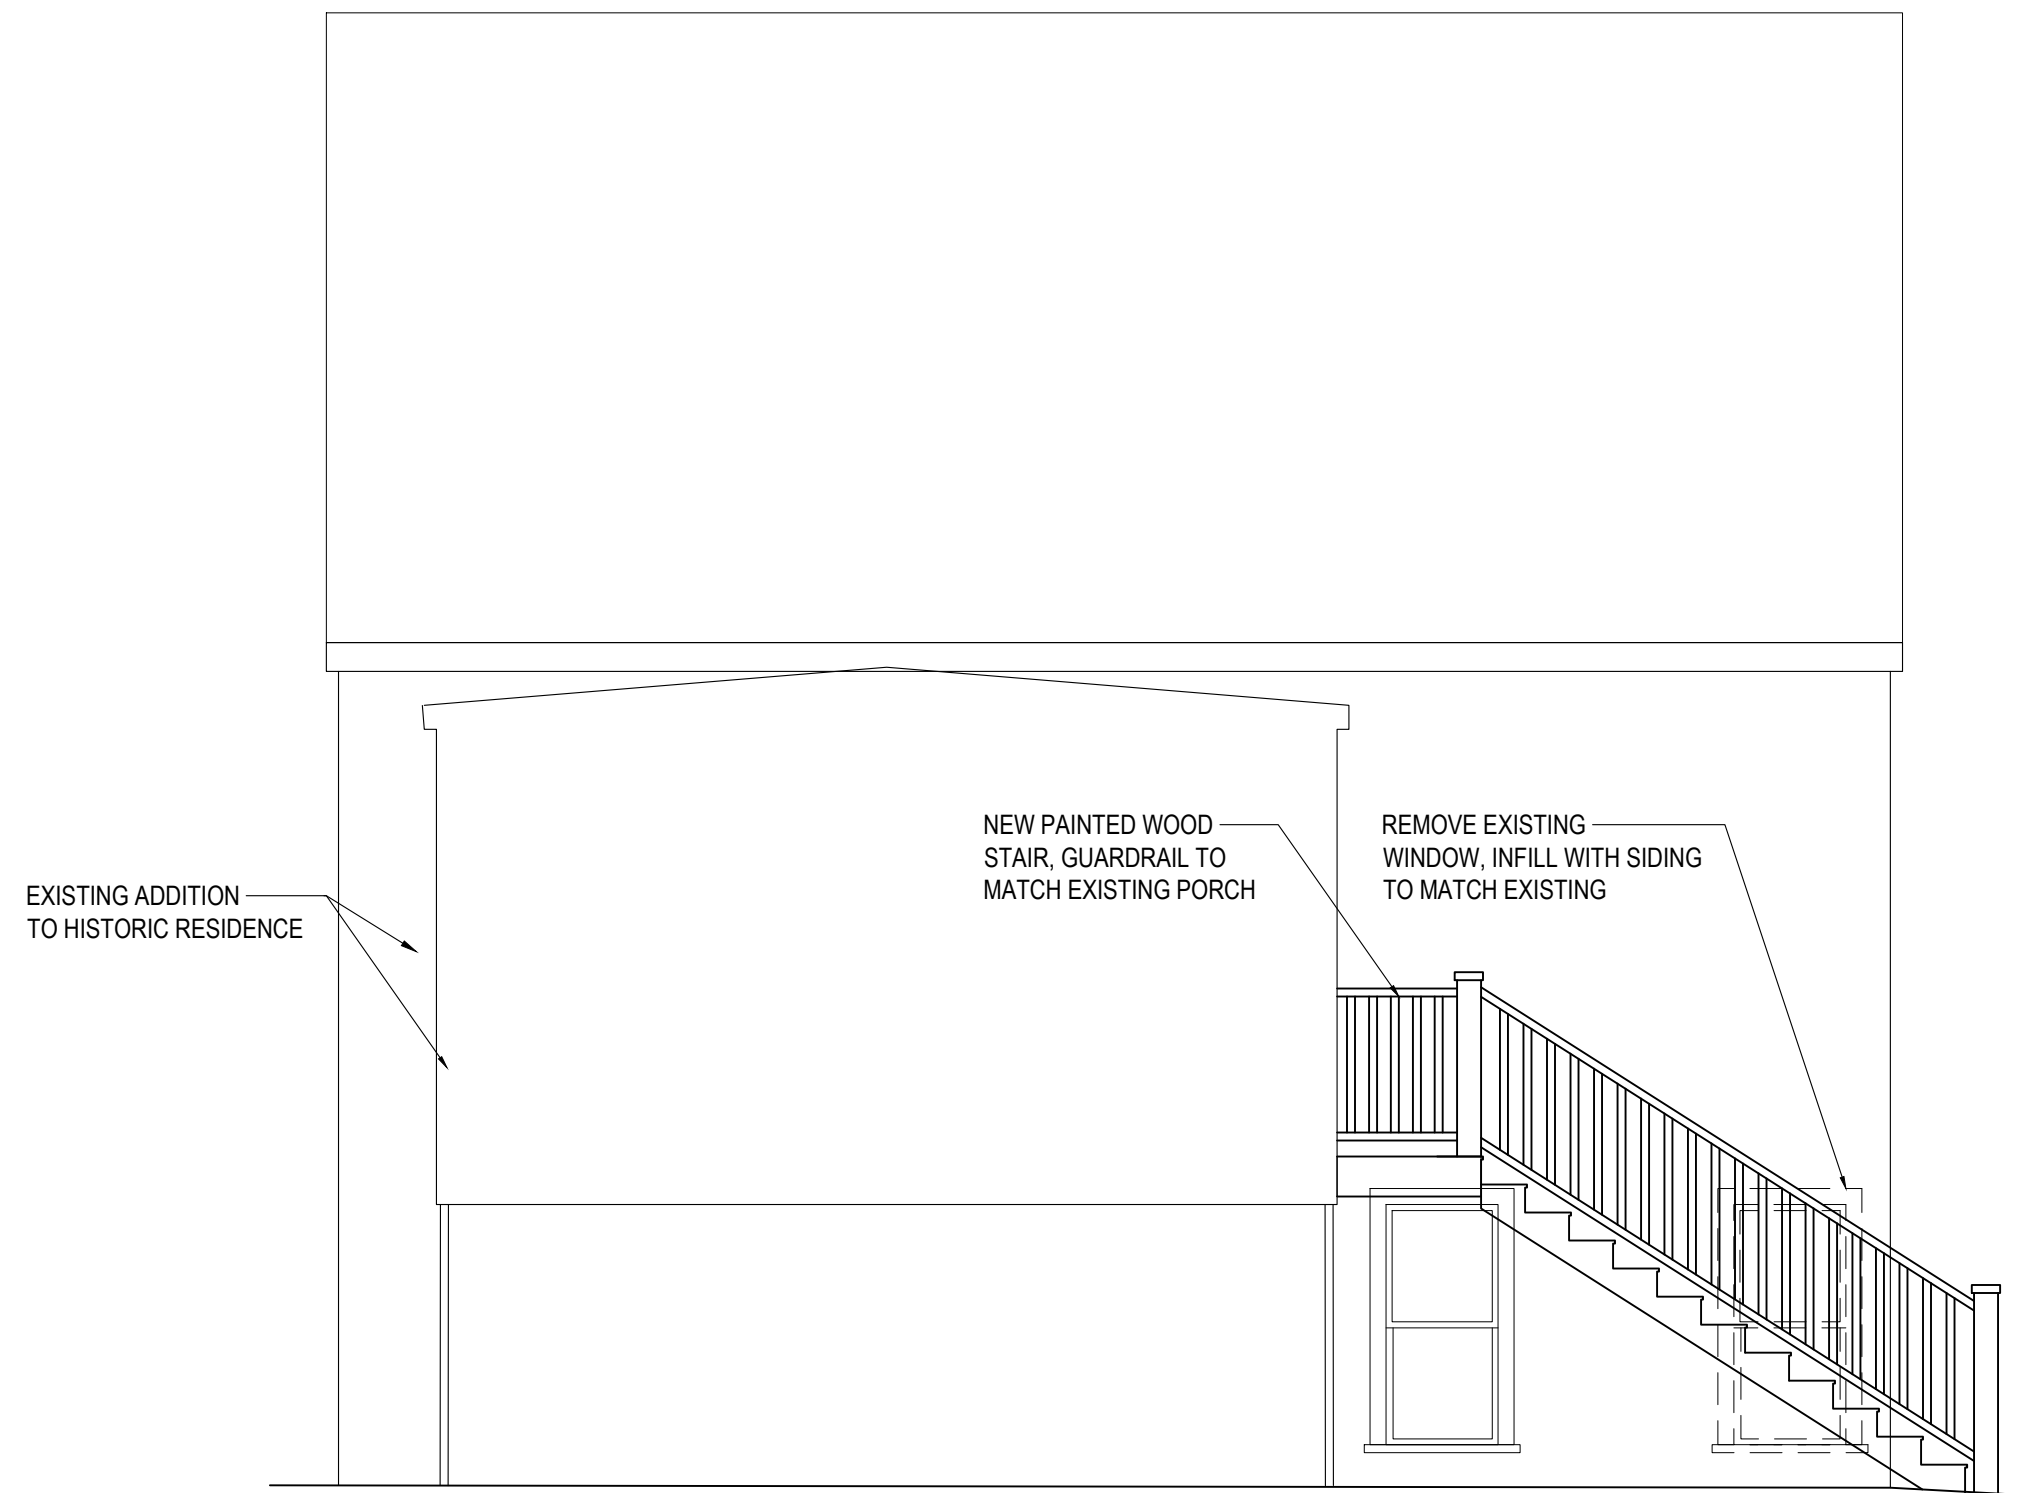
EXTERIOR ELEVATION - NORTH ELEVATION
116 WEST JEFFERSON STREET

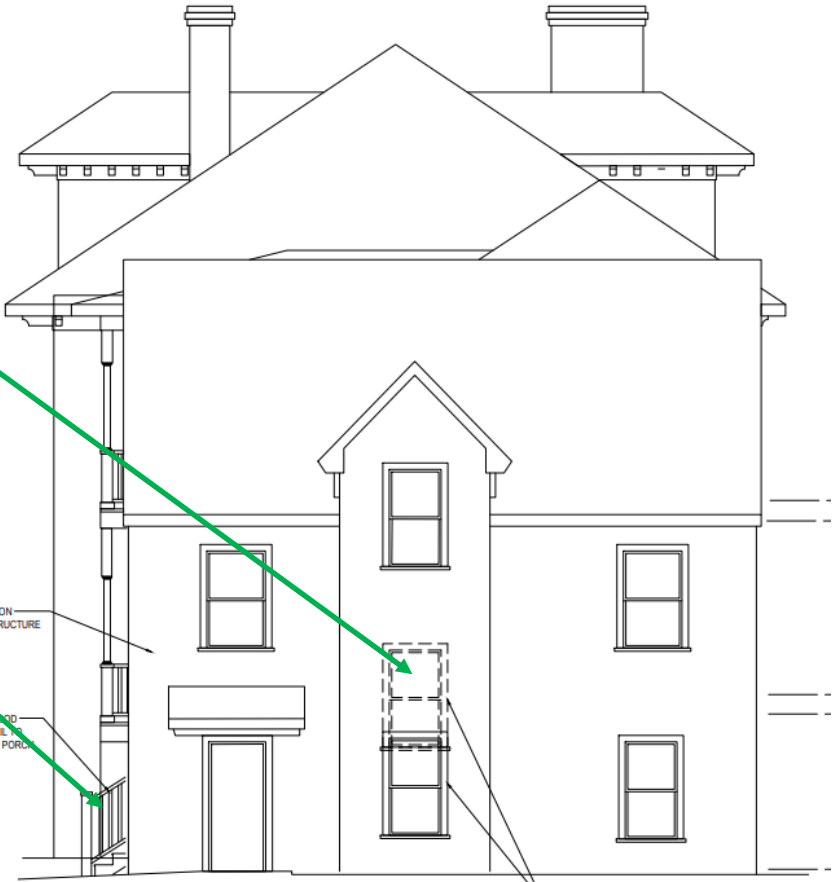
Move window down.
Repair wall to match.

(New stairs at
connector)

EXISTING ADDITION TO HISTORIC STRUCTURE
NEW PAINTED WOOD STAIR, GUARDRAIL TO MATCH EXISTING PORCH
RELOCATE EXISTING WINDOW, INFILL SOING TO MATCH EXISTING

New stairs and door at connector and alterations to contemporary addition: Typically, the installation of new windows and doors requires a high level of scrutiny and review. Given the age of this structure and the builder-grade quality of its materials, staff does not believe additional specificity is necessary for the new doors and windows. Staff recommends approval with the following condition of approval (also from the February 2021 CoA):

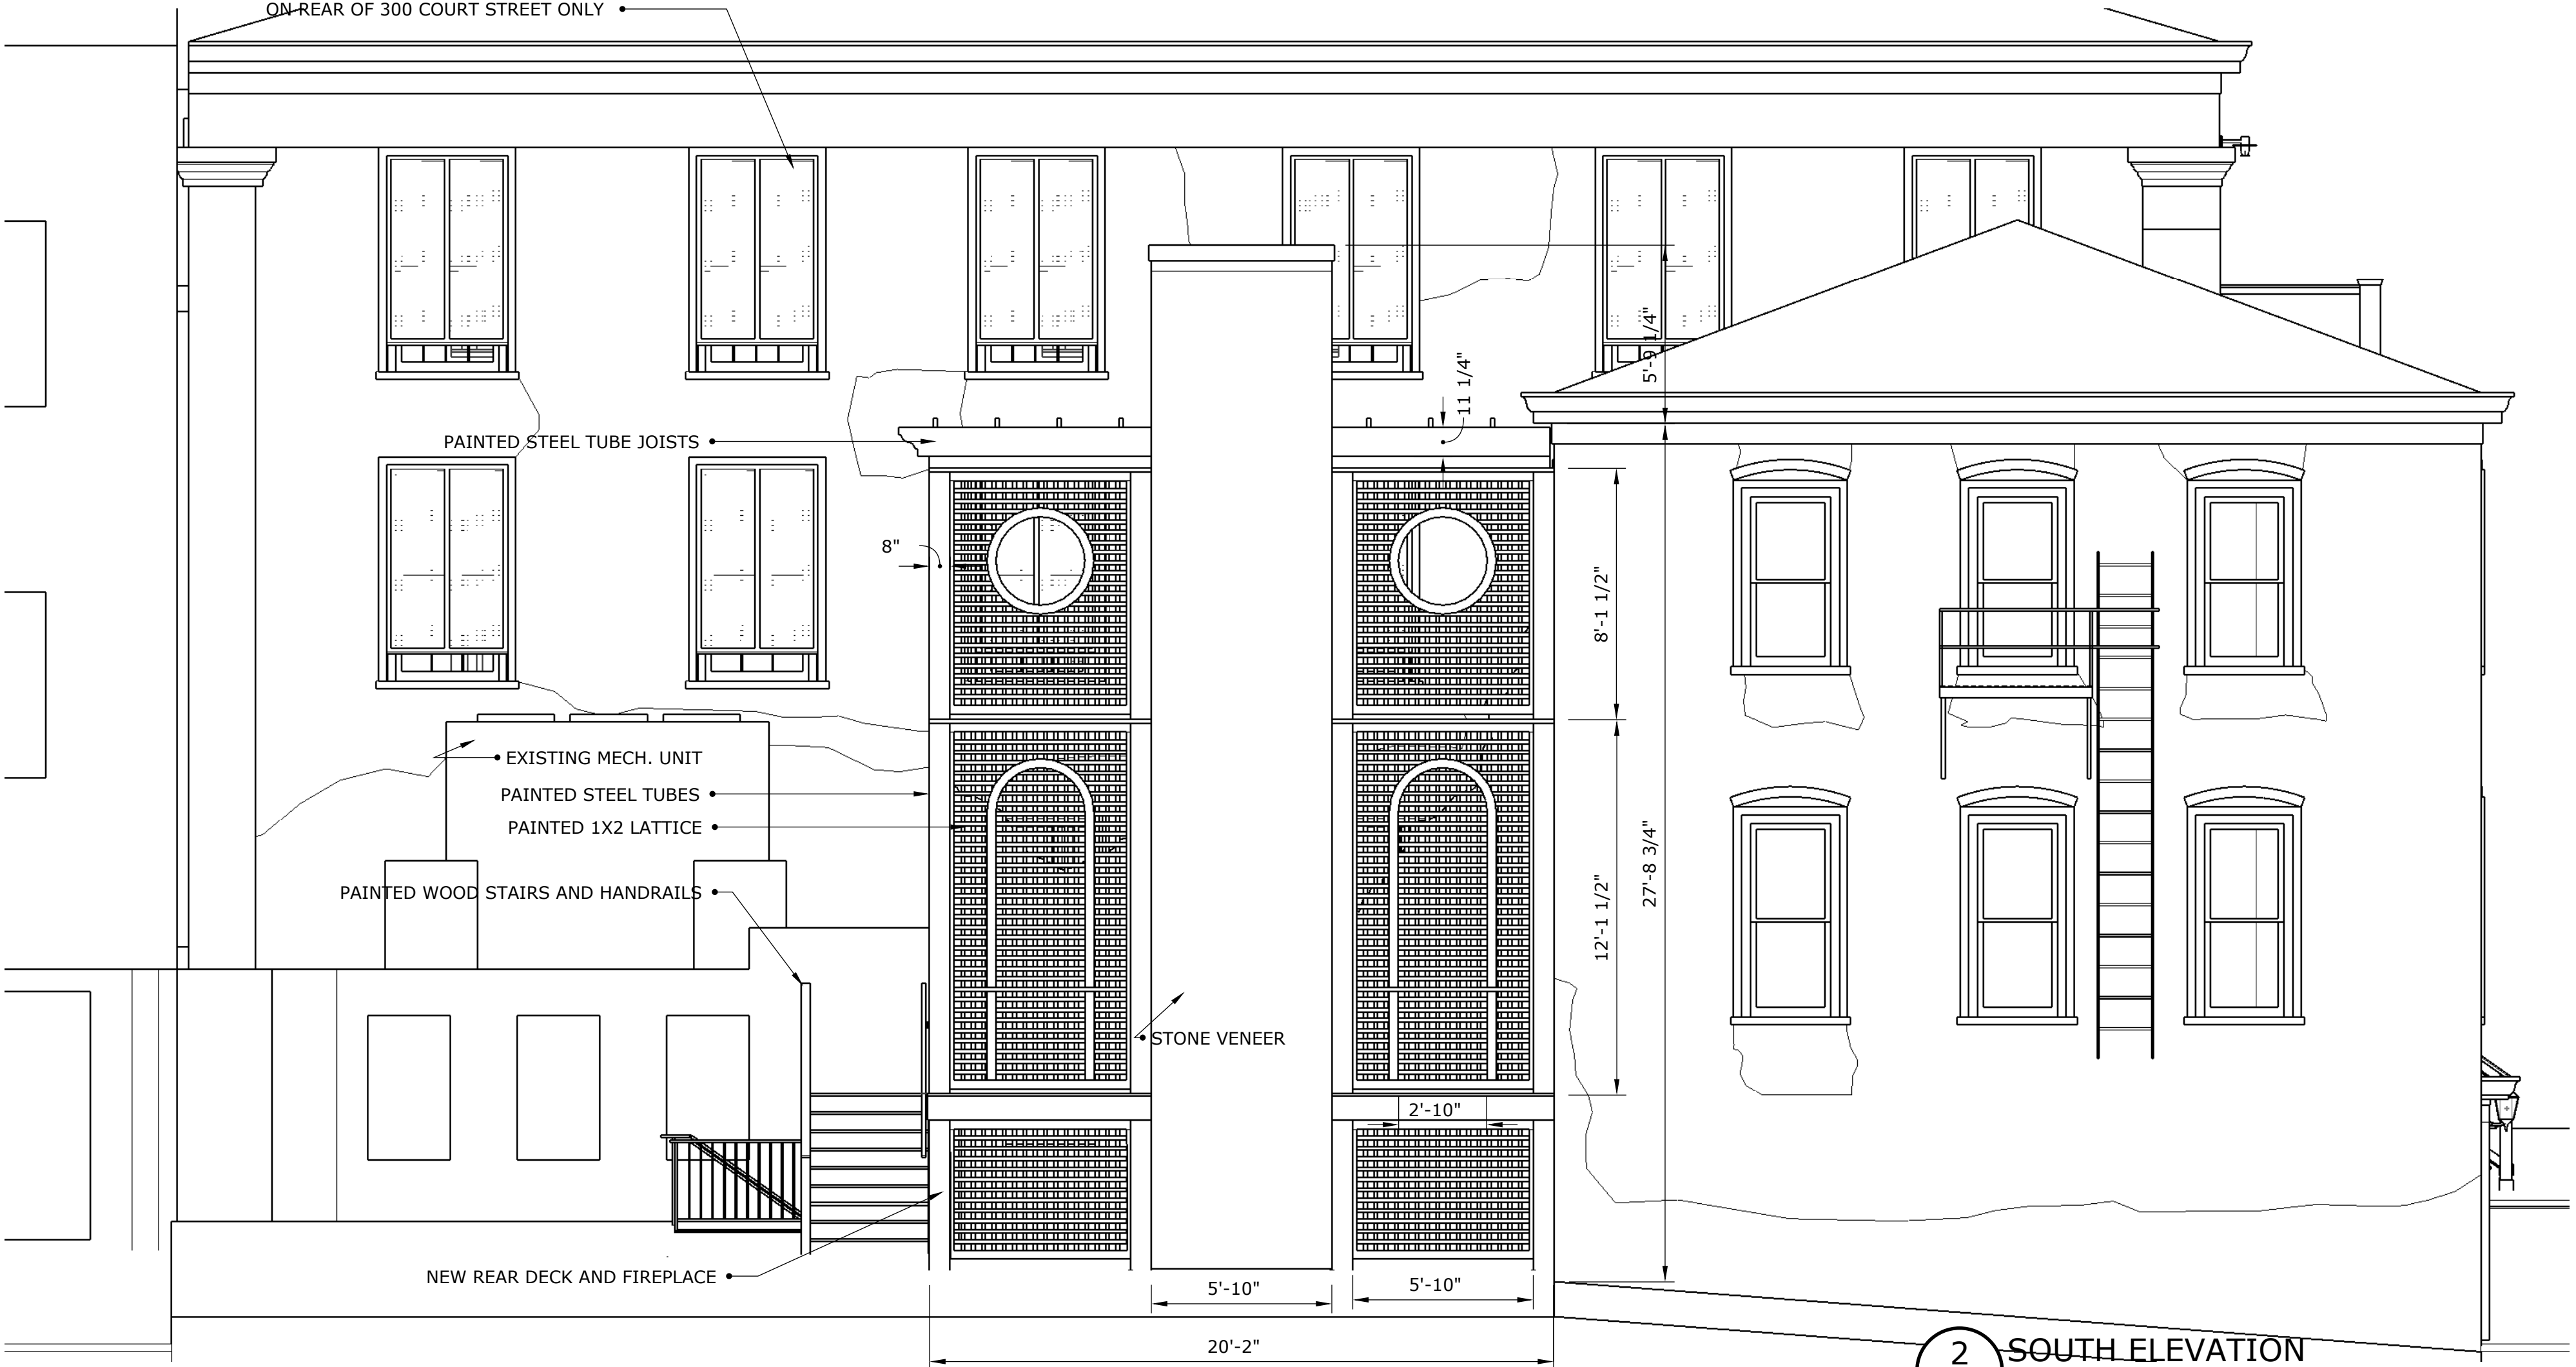
NEW CUSTOM PTD. WOOD BERMUDA SHUTTERS
ON REAR OF 300 COURT STREET ONLY

2 SOUTH ELEVATION
A2 1/4"=1'-0"

REFURBISH EXISTING WINDOWS, TYPICAL

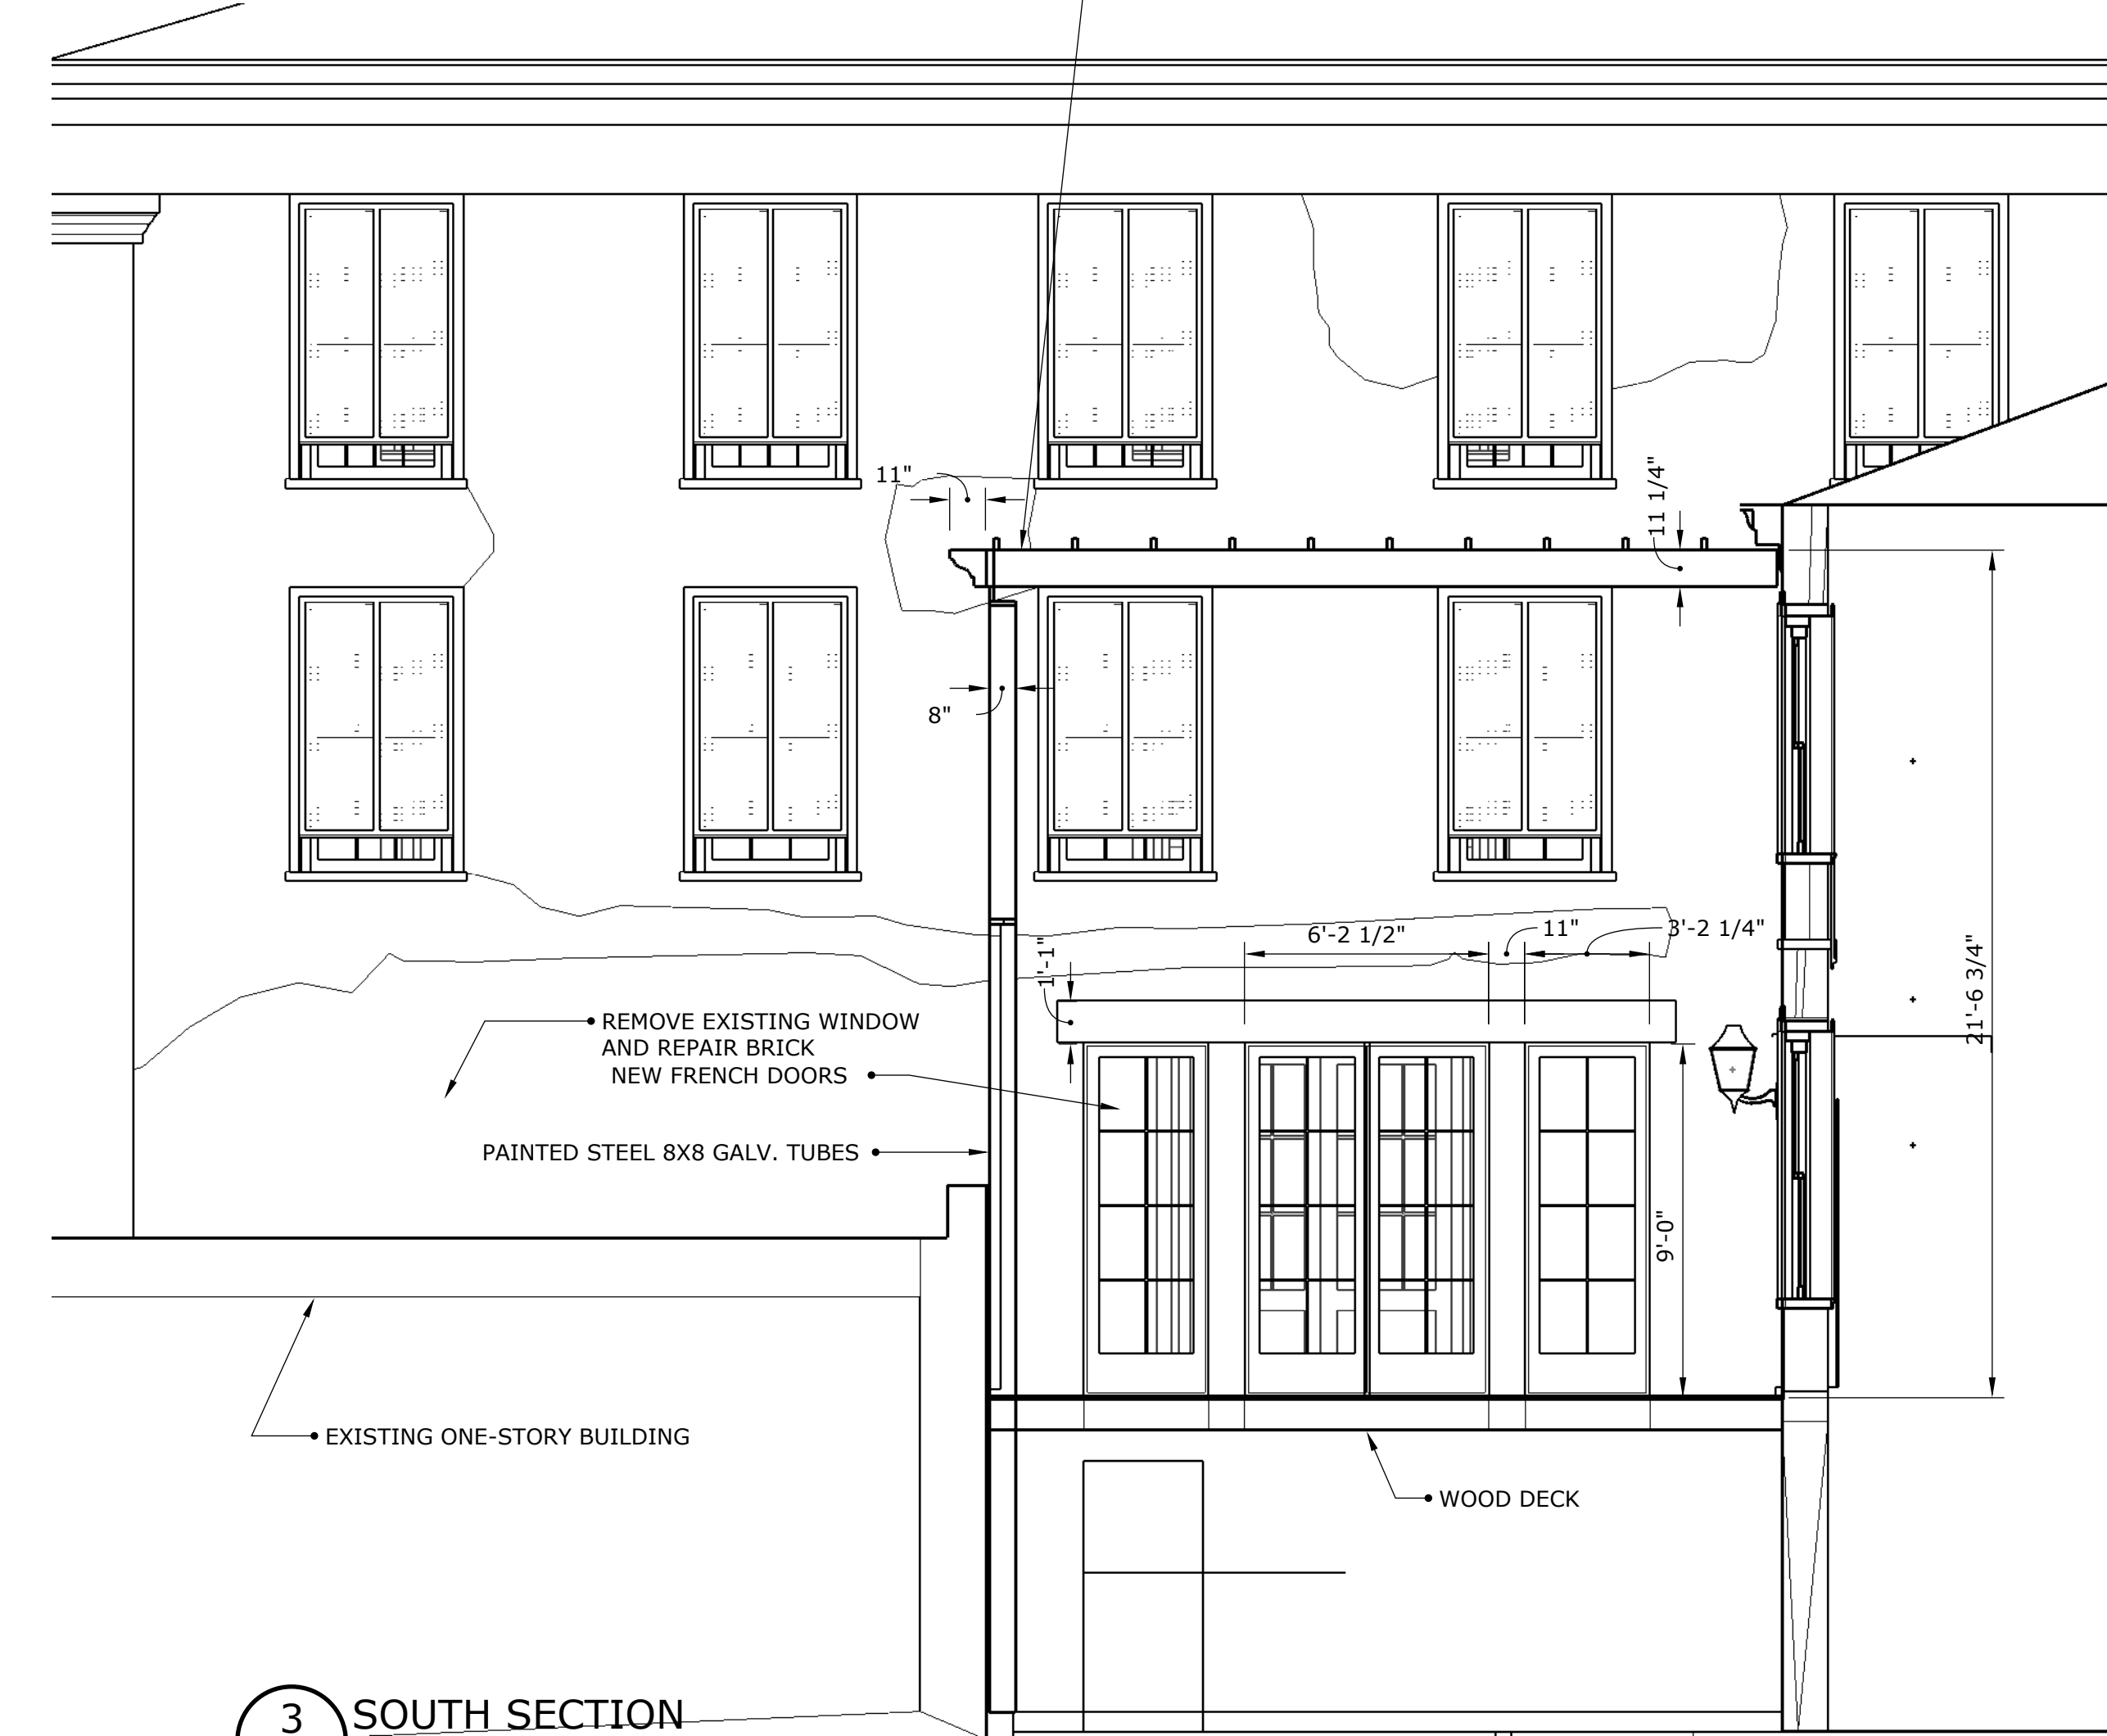
PAINTED STEEL TRELLIS JOISTS 2X12 GALV. STL. TUBE

3 SOUTH SECTION
A2 1/4"=1'-0"
